# OPERATIONAL EXPERIENCES OF CHANDRAPUR- PADGHE HVDC BIPOLE PROJECT

M. Ahfaz,  
Chief Engineer

R. S. Parulkar  
Dy. Executive Engineer  
(Maharashtra State Electricity Transmission Company Limited)

P. B. Chimankar  
Assistant Engineer

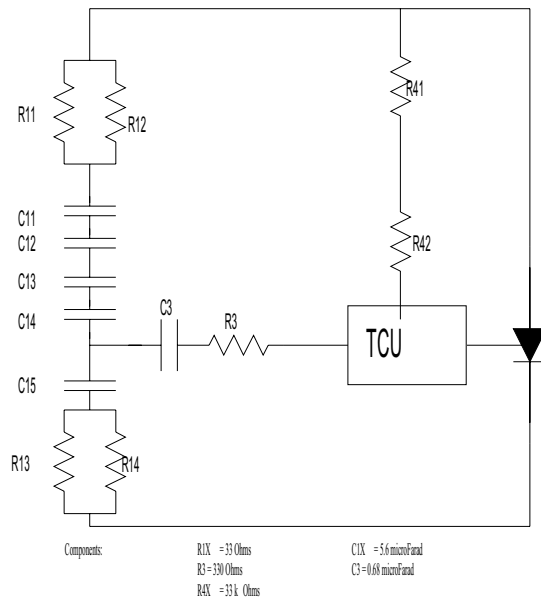
Fig. 2. Thyristor Level with Voltage Divider and Thyristor Control Unit

From the January 2008 to June 2008 the Chandrapur-Padghe link (Pole 1/Pole 2) has failed 10 times due to failure of Snubber Circuit capacitors. After every occurrence the corresponding location were inspected. And in most cases the capacitor C1X found either burst or with their capacitance very much deviated from the permissible once. Due to bursting of the capacitors the light guides, which are placed over these capacitors, also got burnt and damaged the light guides.

found values beyond the permissible limits. Also on approximately 60% of total capacitors small leakage at the capacitor terminals in the form of black spot were observed.

The investigation was carried by M/s. ABB Ltd. Investigation report says that the capacitors have developed minor leaks around the top sealing, allowing the insulating oil to absorb moisture from the air. The increased moisture level of the oil and the subsequent loss of the insulating capacity have caused accelerated ageing of the capacitors. The voltage withstand capability of the capacitors has been reduced leading to degeneration and in some cases destruction.

M/s. ABB's recommendation is to replace all the electrolytic capacitors in the Snubber Circuit with the gas-filled capacitors.
