# Study of Impacts of Transportation on PV Modules

**Master of Technology  
(Microelectronics)**

**Department of Electrical Engineering  
Indian Institute of Technology, Bombay**

**Jun 2021**

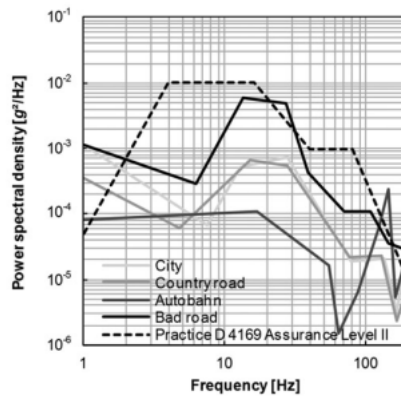
Figure 2.4: Measured reduced power spectral densities in a vertically stacked transport stack reported by Köntges et al. [5].

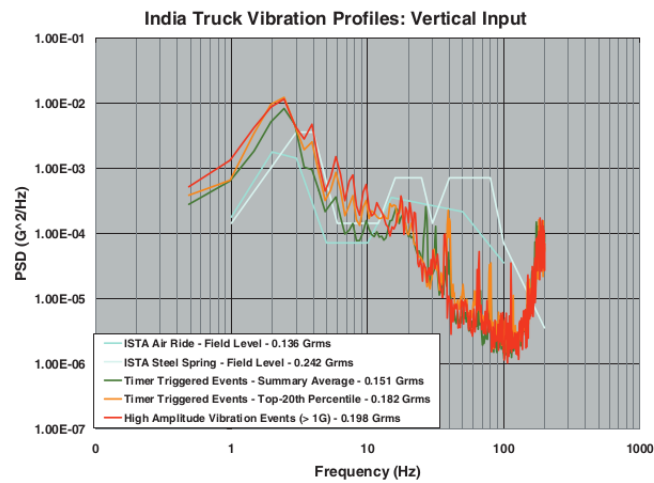
Figure 2.5: PSD profile for the truck vibration on Indian roads along the vertical axes reported by Singh et al. [4].

vibration intensity levels were higher in India as compared to those from North America and Europe. The truck and rail vibration profiles shows excessive lateral and longitudinal movement. Hence, a detailed study is necessary for the laboratory simulation of the transportation of PV modules on Indian roads .

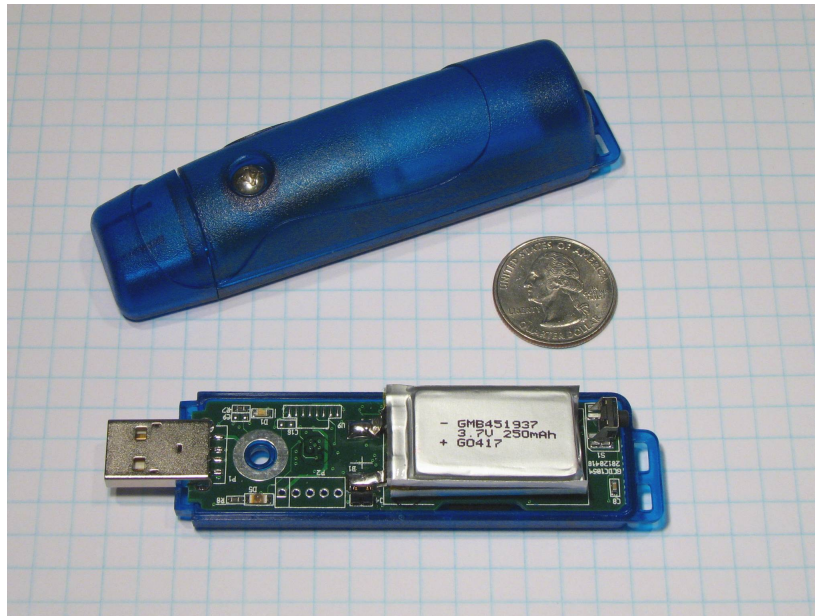
Figure 3.1: GCDC X16-4 accelerometers [6].

Gulf Coast Data Concepts (GCDC) X16-4 accelerometers (Figure 3.1) were used for the experiments [6]. This is a 3-axes accelerometer with  $\pm 16g$  acceleration range. It can sample the 3-axes acceleration data up to 800 Hz. The lifetime of the built-in batteries were limited for few hours. Hence, additional battery packs or power banks were used to extend the lifetime of the data loggers.

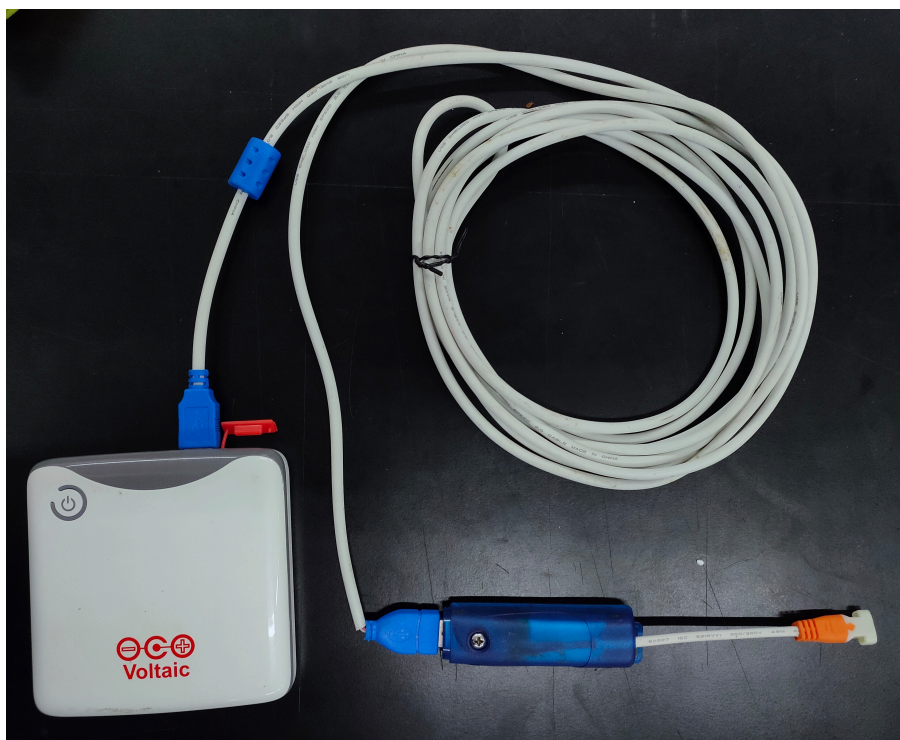
Figure 3.4: GCDC X16-4 accelerometer connected to Voltaic power bank.

Seven GCDC X16-4 accelerometers [6] with extended battery backup were used (Figures 3.3, 3.4). The accelerometers were attached to the center of the backsheet with 3M 950

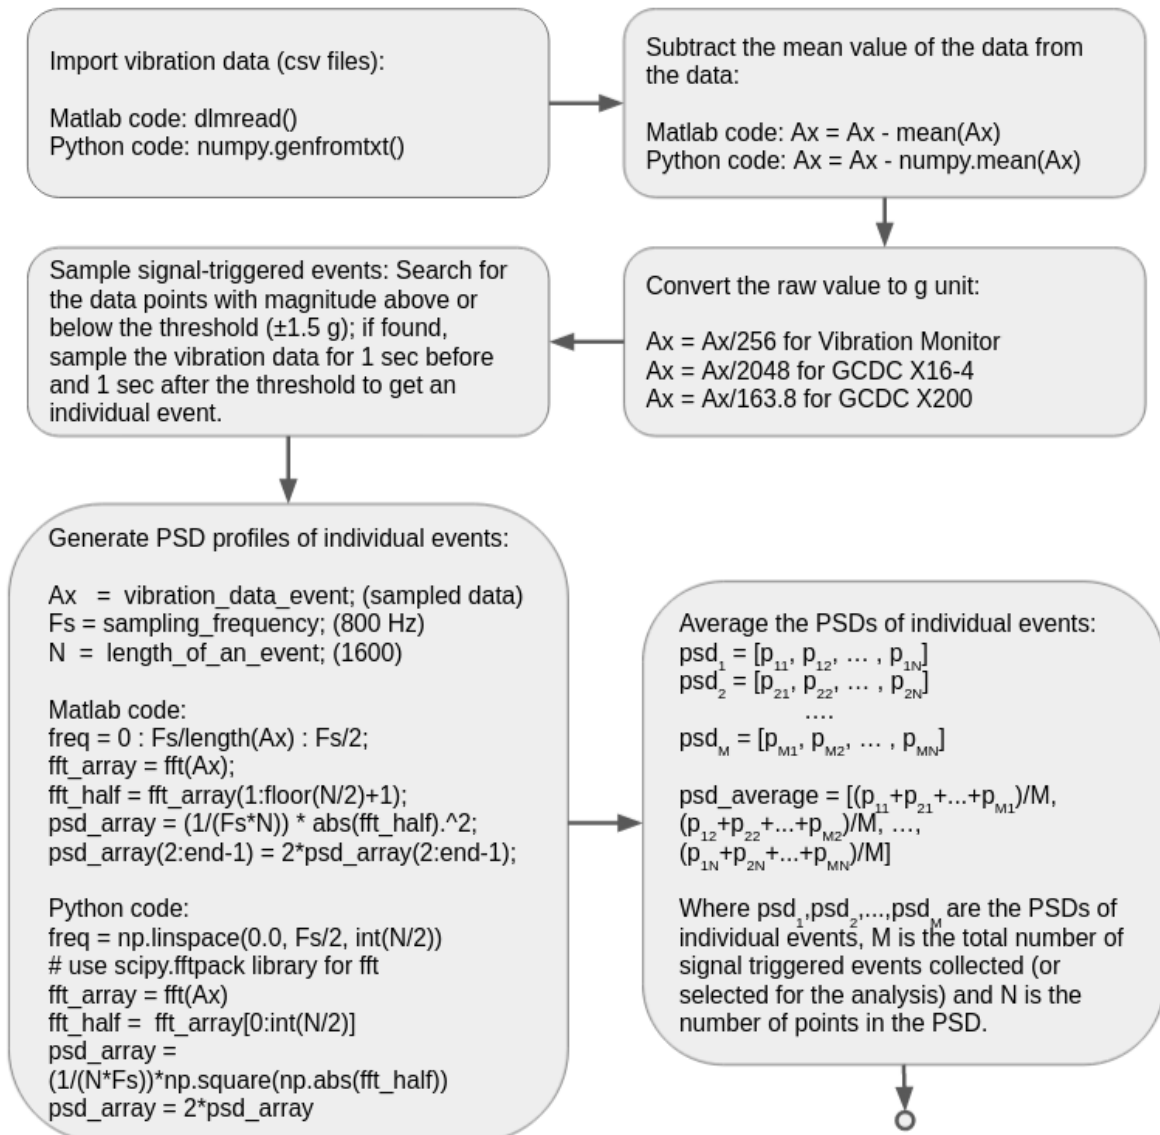
Figure 3.7: Flow chart explaining PSD plot generation (part 1 of 2) [7].

Transportation vibration data were analyzed using Power Spectral Density (PSD) profiles. From the continuously recorded data, static data files (when the vehicle was not travelling) were removed. This can be performed by viewing the entire data in the time domain and manually separating the files where the truck was travelling and stationary. This is not important when signal-triggered events were sampled. Signal-triggered and

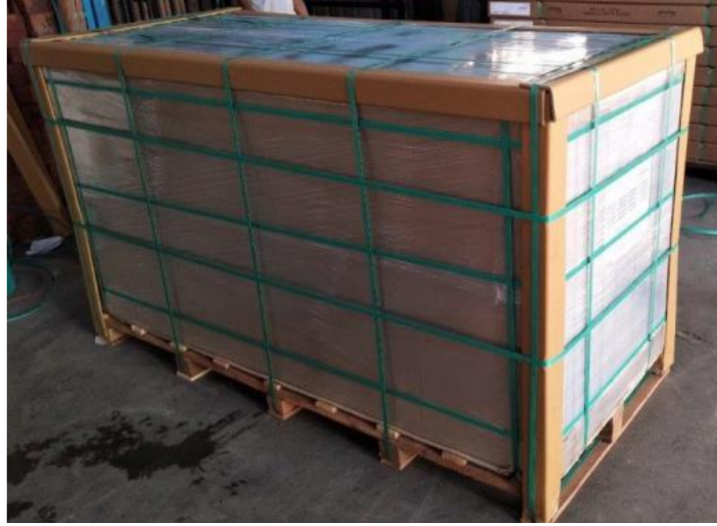
Figure 4.1: A standard pallet containing 20 PV modules.

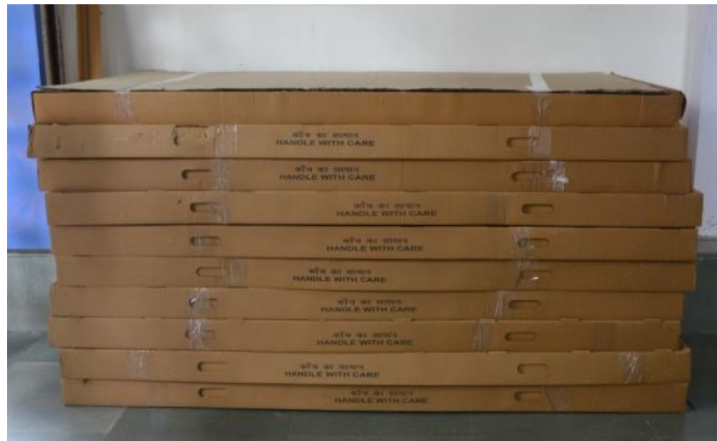
Figure 4.2: A stack of 10 cassette type of packages containing 2 modules each.

The second type of packing used was Cassette type of packing which contained only two modules, placed with front glass facing each other. There would be a thick cardboard in between the two to separate them. This would be covered on the top and bottom

using cardboards and tightened with plastic straps or adhesive tapes, as shown in Figure 4.2. This packaging method is mainly followed for transporting modules for low volume residential applications.

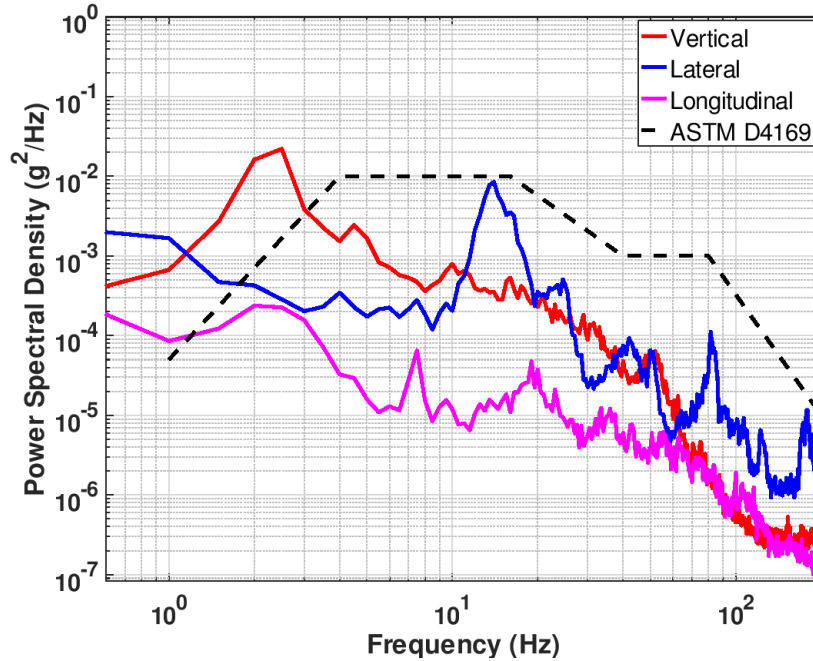
Figure 4.6: PSD of vertical, lateral and longitudinal vibration data collected from a cassette packing for Experiment-2 (A new crack generation and 6 crack transformations were detected from EL images).

In Experiment-2, the PSD of vertical, lateral and longitudinal vibration are shown in Figure 4.6. The vertical vibrations at low frequency were seen to be higher than specified in the ASTM standard. A peak at around 15 Hz was also seen in the PSD profile of lateral vibrations. Similar results were observed for the pallet package transportation where the module plane was perpendicular to the lateral direction. From this observation, we may understand that using a general transportation standard like ASTM D4169 is inadequate for PV applications. Not only the vertical axis vibrations, but the vibrations from the axis that was perpendicular to the module plane also gives mechanical stresses to PV module. Many PV module manufacturers in India are preferring vertical placement of PV modules inside the pallet to avoid the severe vibrations along the vertical axis. In that

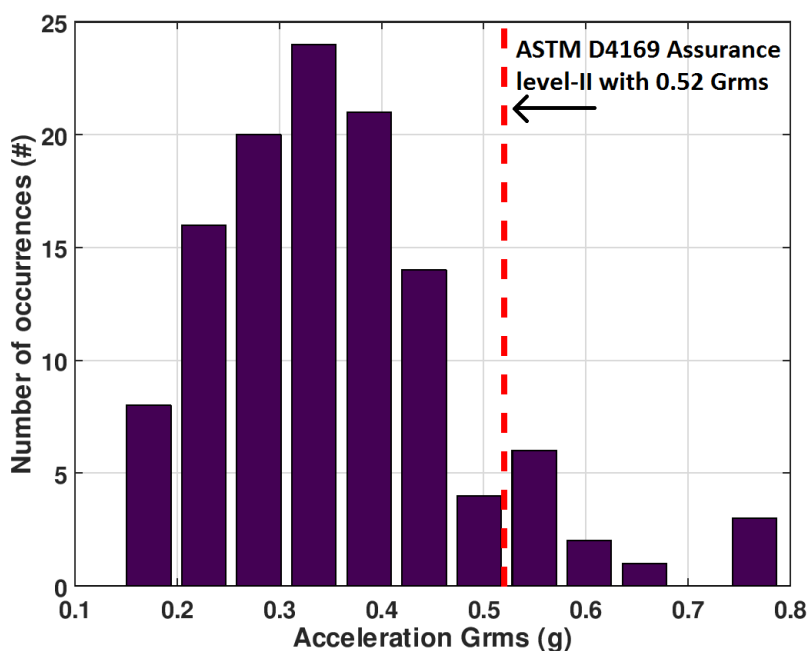
Figure 4.7: Histogram of the accelerations from Experiment-2 for the manual handling of a cassette packing.

The vibration profile obtained for the PV module transportation on Indian roads are not fitting with the ASTM D4169 Assurance Level II, the main reference of IEC 62759-1:2015. The vibration levels are severe than ASTM D4169 for the lower frequencies (1-3 Hz). The PSD plots for vertical placement of modules shows immoderate lateral vibrations. Manual handling of modules was found to result in high values of acceleration, up to 15g. The

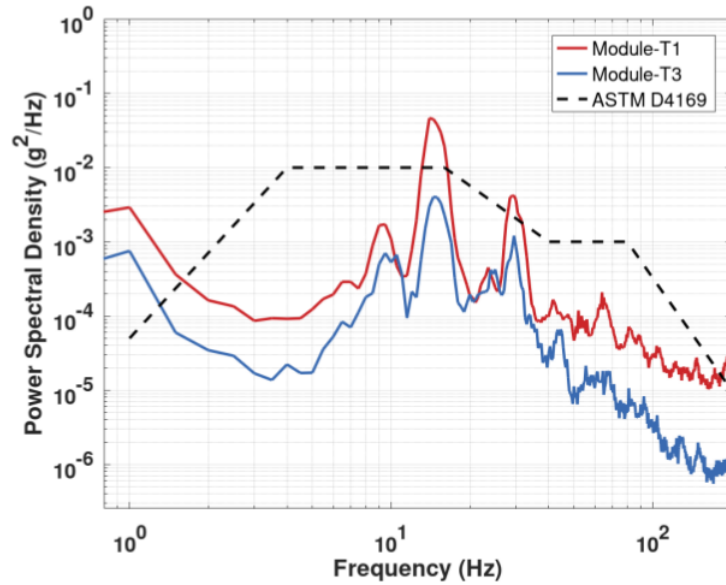
Figure 5.3: Lateral vibration profile of the PV modules T1 and T3.

The lateral vibration profiles of all PV modules shows a peak value at around 15 Hz (Figures 5.3, 5.4). Similar results were observed in previous experiments. Comparing the PSD profiles of lateral vibrations experienced by the PV modules T1 and T3 shows that the module T2 experienced lesser vibrations compared to module T1. i.e., the vibration

experienced by the PV module placed glass facing glass was lesser than the vibration experienced by the PV module placed front side facing backsheet (Figure 5.3).

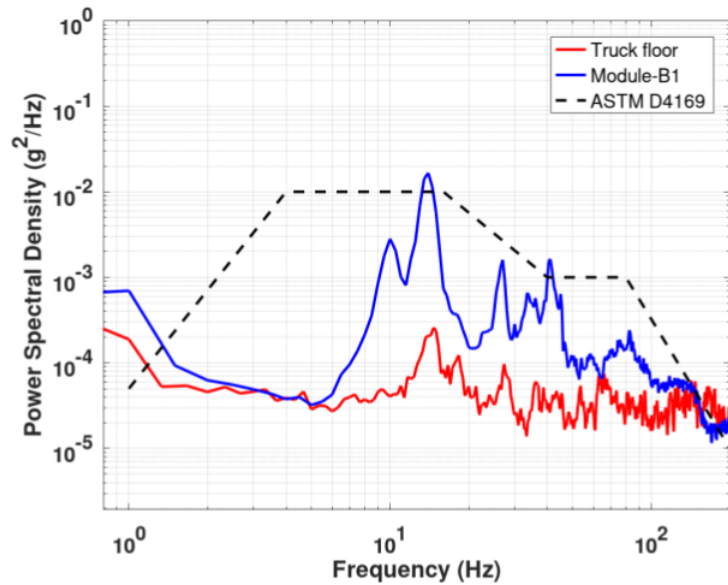
Figure 5.5: Lateral vibration profile of the PV module B1 and the floor of the truck.

The vibration data collected from the floor of the truck shows insignificant lateral vibrations compared to that of PV modules (Figure 5.5). The occurrence of peak in the

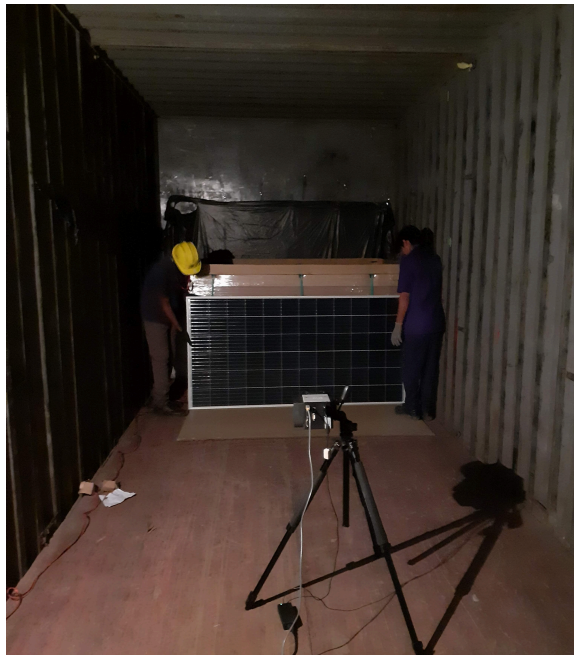
Figure 6.1: Dark room setup made for EL imaging inside the container (wooden floor).

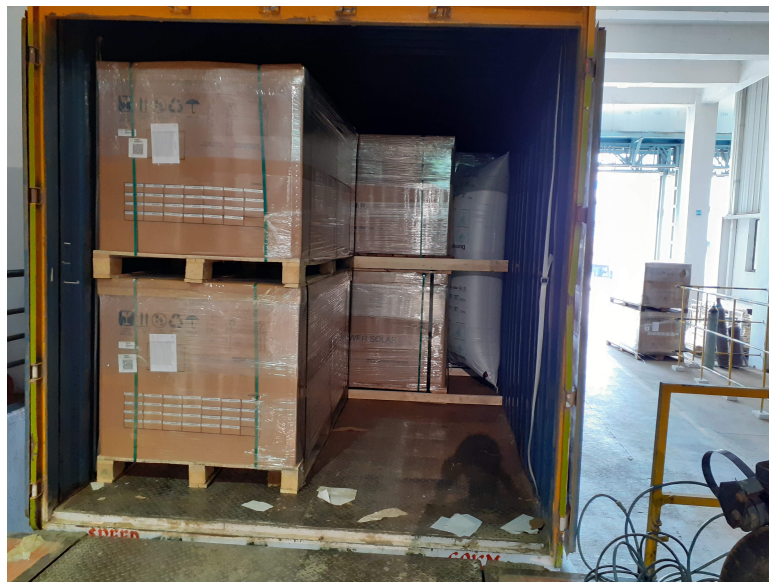
Figure 6.2: PV module pallets loaded inside the container (metal floor).

Crystalline silicon PV Modules of size 1.95 m X 0.99 m with 72 cells and maximum power of 320 W were used in this study. Two containers were used for transporting 35 PV module pallets. One container had wooden floor (Figure 6.1) and other container had metal floor (Figure 6.2). The transportation started from the manufacturing unit of Company X, Bangalore and ended at the installation field at Hyderabad covering around 800 kms. Out of 35 PV module pallets transported, 34 of them were packed with 27 PV modules and 1 of them packed with 18 PV modules. This was just to match their total number of PV modules for shipping. 25 PV modules were kept under observation. These 25 PV modules were distributed in 5 pallets. In these 5 pallets, 5 PV modules which were under observation distributed as two PV modules at both the ends and one PV module at the middle.

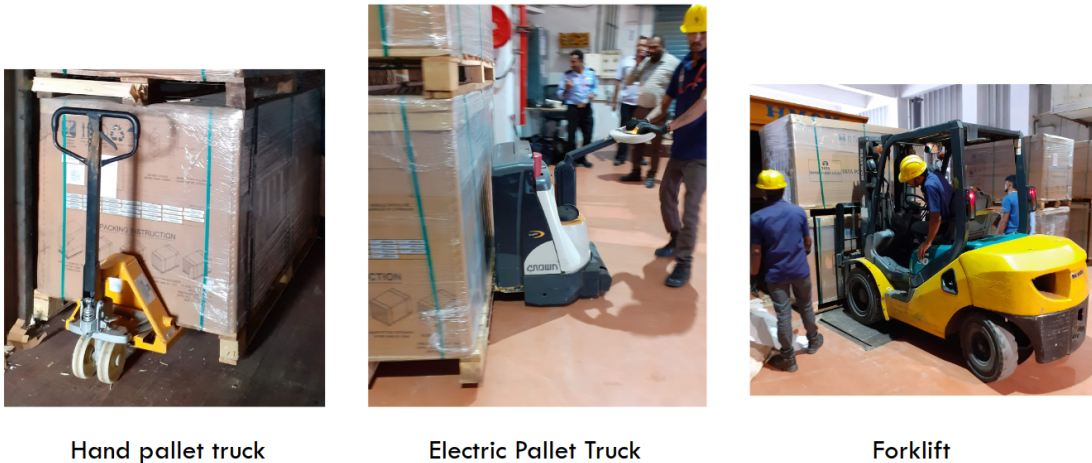
Hand pallet truck

Electric Pallet Truck

Figure 6.6: Different pallet handling practices used in the industry.

marked in red. The pallets were handled using a forklift, electric pallet truck and hand pallet truck as shown in Figure 6.6. Figure 6.1 shows the dark room setup for the EL imaging inside a container. Figure 6.4 shows the arrangement of PV modules inside the pallets P1, P4 and P5. Figure 6.5 shows the arrangement of PV modules inside the pallets P2 (bottom) and P3 (top).

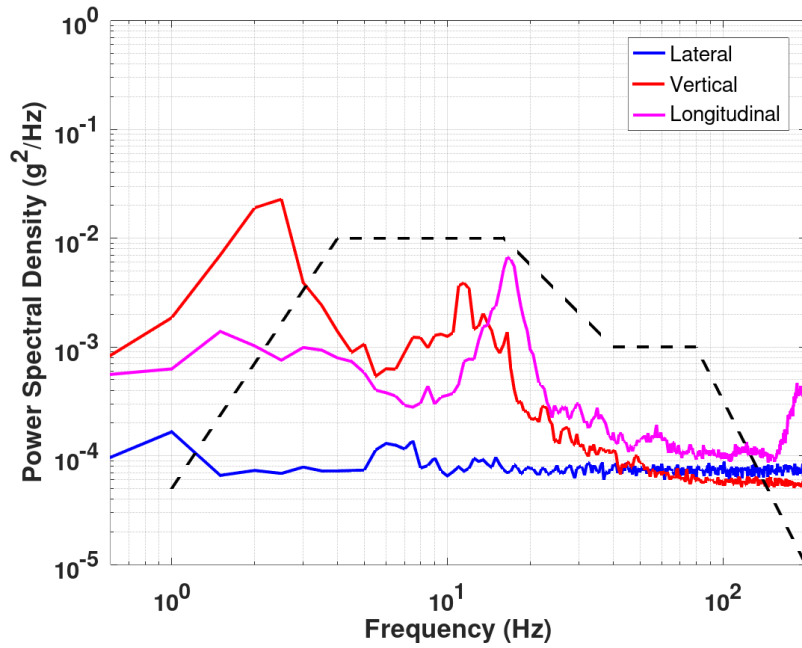
Figure 6.13: PSD profile of 3-axes vibration data collected from the PV module inside pallet P3; The axis perpendicular to the PV module plane was oriented towards longitudinal direction of the container.

Figure 6.13 shows the 3-axes PSD profile of the vibration data collected the PV module inside pallet P3. The axis perpendicular to the PV module plane was oriented towards longitudinal direction of the container. In the PSD profile, a peak in the longitudinal vibration data was observed in 10-20 Hz range. Previous experiments had similar peak in the lateral direction when the axis perpendicular to the PV module plane was along lateral direction of the truck. Hence, it may be observed that, irrespective of the direction of the truck, PV module experiences vibration in 10-20 Hz range along the axis perpendicular

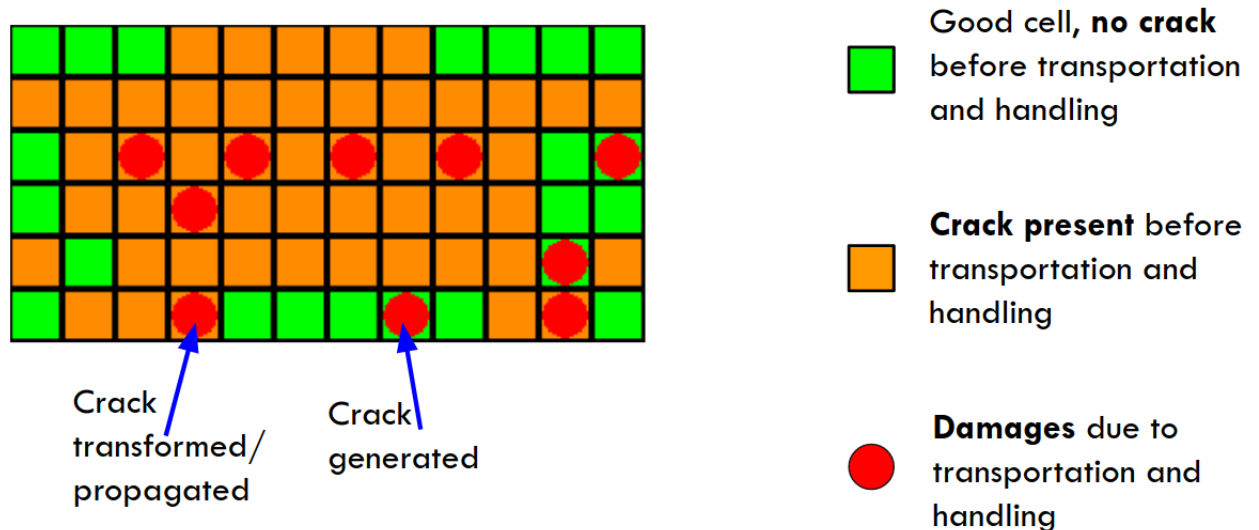
Figure A.1: Analysis of EL image – classification scheme.

Figure [A.1](#) shows the classification scheme generated from the micro-crack analysis of the PV module from EL images taken before and after transportation. It contains boxes corresponding to each cell of a PV module. A green box indicate a good cell, with no cracks before and after transportation. An orange cell indicate a cell with one or more cracks present before transportation. A red circle indicates damages due to transportation or handling. Here a red dot on green box indicates crack generation and a red dot on orange square may indicate a crack transformed or propagated.

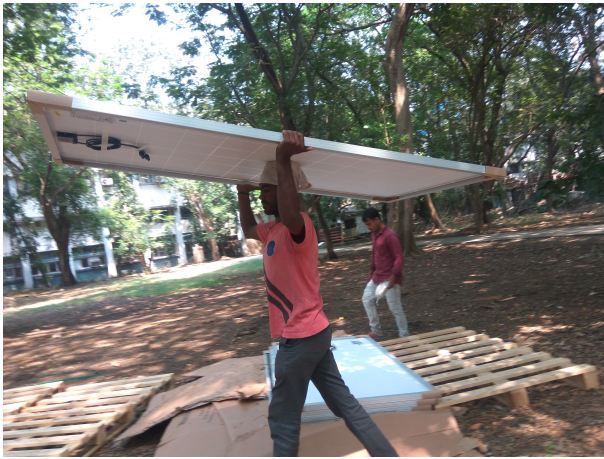
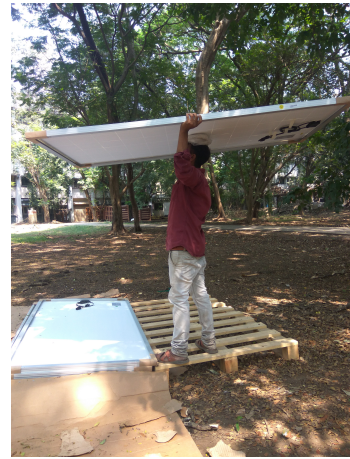
Figure C.1: Improper manual handling practices noticed.

Different manual handling practices are used in the industry to move PV modules starting from the manufacturing unit to the installation site. Some of the improper handling methods stresses the module and may result in micro-cracks. Figure [C.1](#) shows a person carrying PV modules on his head. This might exert heavy mechanical load on the PV module.

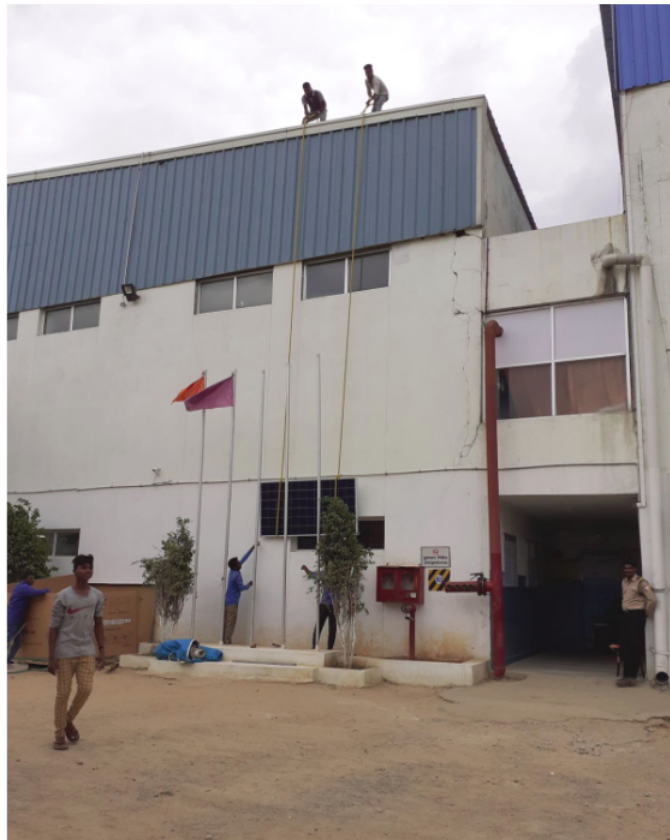
Figure C.2: Risky manual handling practice.

Figure [C.2](#) shows shifting the PV modules from the ground to the terrace using ropes. The modules were hitting the wall which may exert mechanical stress on the PV module. Hence, proper manual handling practices need to be established and the workers must be trained, to reduce the mechanical stress exerted on the PV modules during manual handling.
