# **Encapsulant Discoloration in Photovoltaic Modules in Different Climates of India and its Correlation with Hot Cells and Electrical Degradation**

**Doctor of Philosophy**

**Shashwata Chattopadhyay**

Department of Energy Science and Engineering

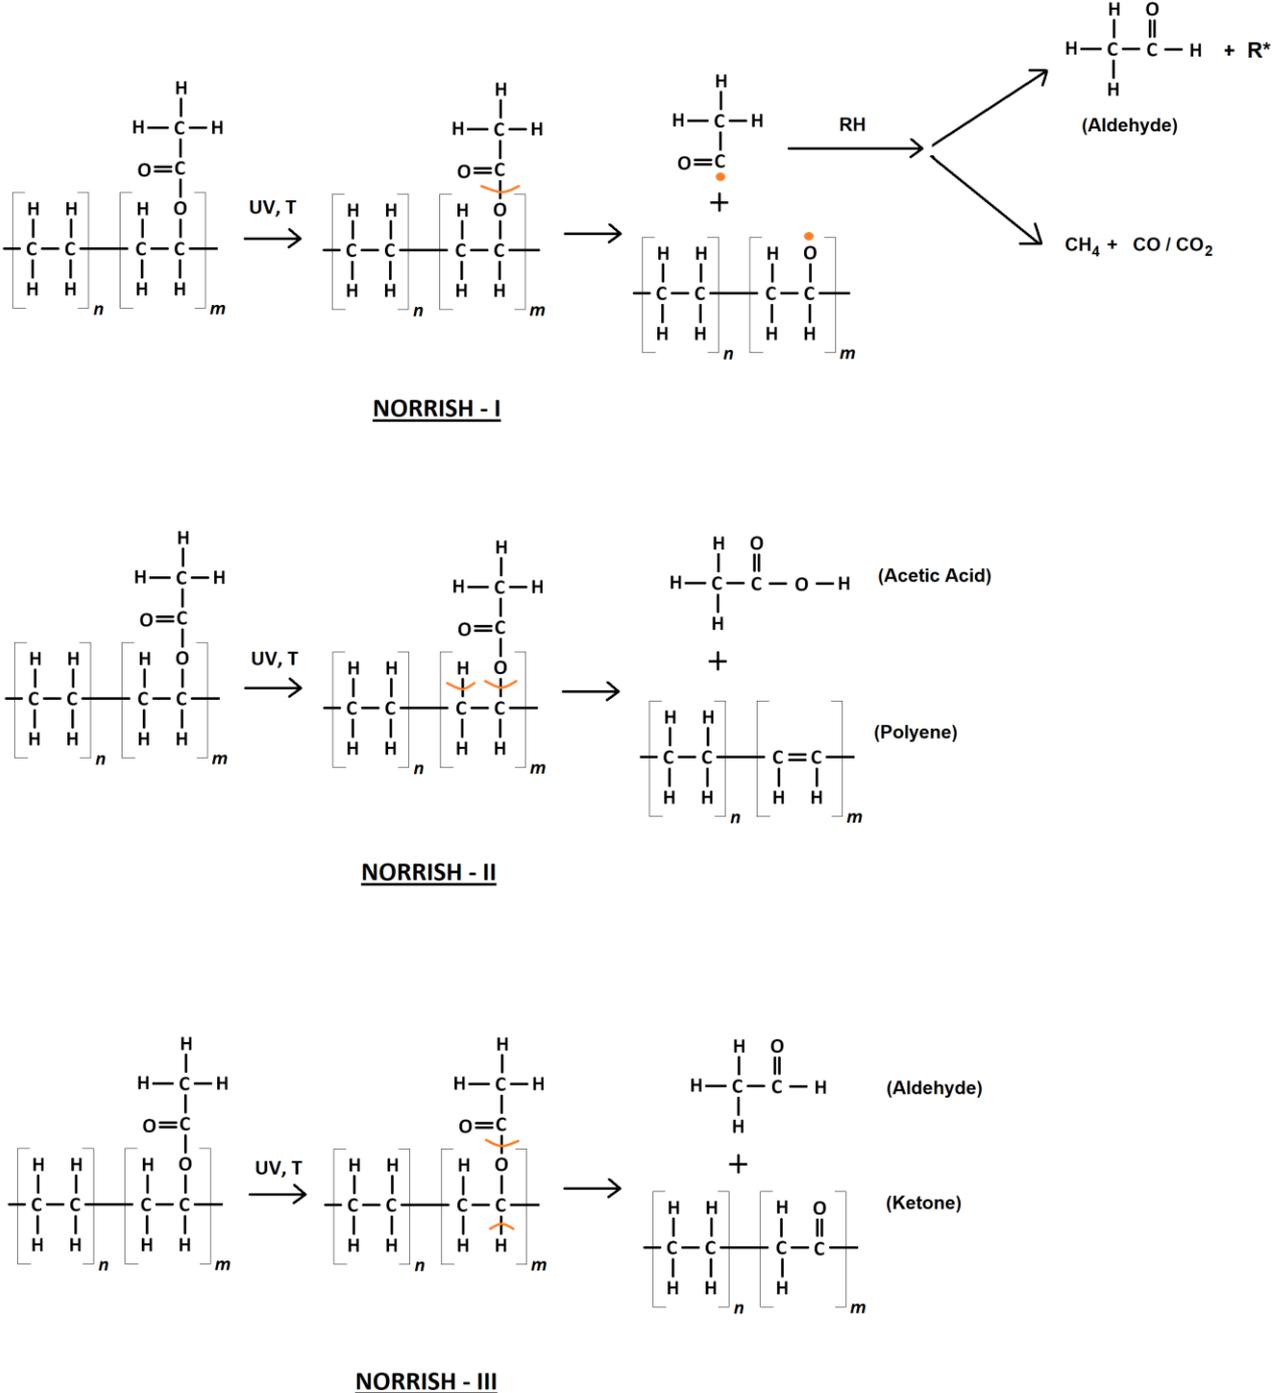
Fig. 2.2: Reaction pathways for degradation of EVA (based on ref. [48]), showing the bond cleavage positions (marked with orange color). All degradation mechanisms are associated with the VA group.

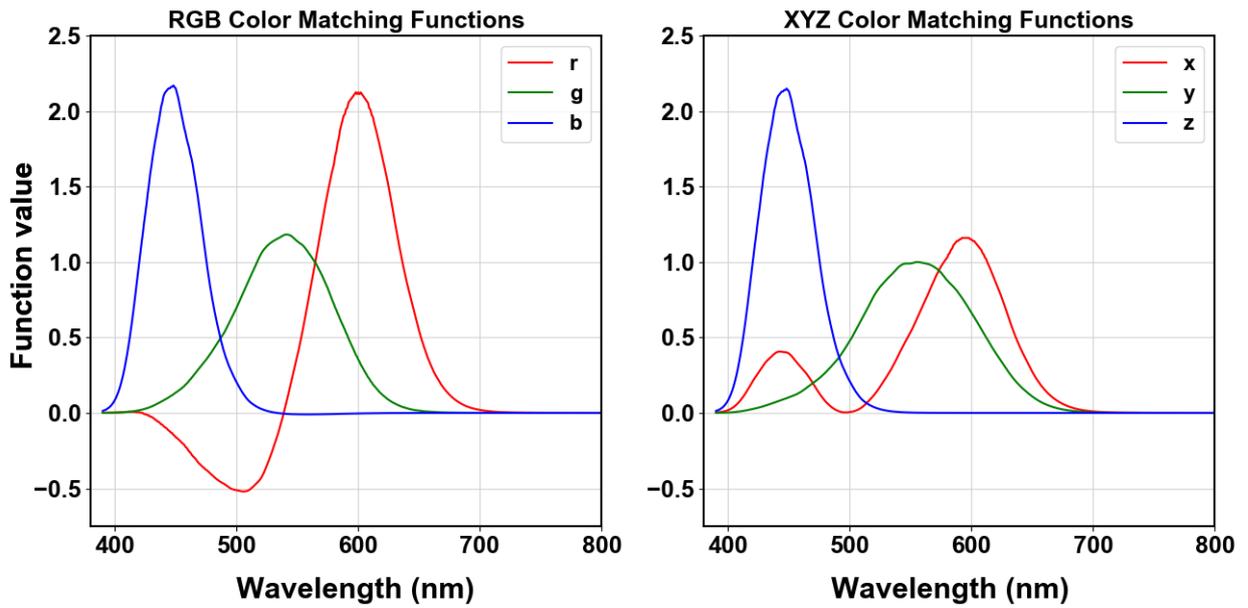
Fig. 2.3: Color matching functions for generating any color based on three primary color wavelengths - (a) RGB primaries, and (b) XYZ primaries (after Xrite [62]).

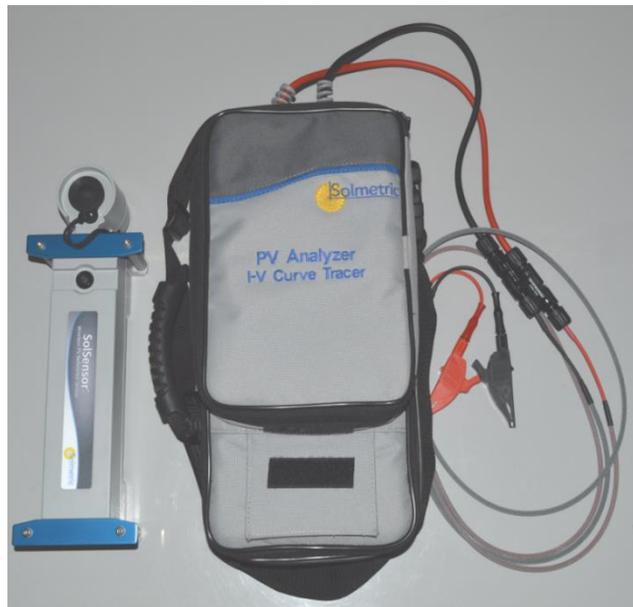
Fig. 3.1: Outdoor current - voltage characterization – (a) schematic diagram of the measurement setup, and (b) portable *I-V* tracer (Solmetric PVA-1000S) used for outdoor characterization of PV modules.

The  $I$ - $V$  characteristic was measured during the field surveys using a portable  $I$ - $V$  tracer (make: Solmetric, model: PVA 1000S). The accuracy of this instrument is 0.5% ( $\pm 0.04$  A) in current and 0.5% ( $\pm 0.25$  V) in voltage [93]. The Solmetric  $I$ - $V$  tracer comes equipped with a Solsensor unit which has a silicon photodiode for irradiance measurement and also connection ports for thermocouples to measure the PV module temperature. During measurement, the thermocouple is attached to the backsheet at the center of the solar panel, below a solar cell. The irradiance measurement accuracy is 2% (typical). Figure 3.1 (a) shows the schematic diagram for outdoor  $I$ - $V$  measurement, and the Solmetric  $I$ - $V$  tracer along with the Solsensor unit (on the left side of main unit) is shown in Fig. 3.1(b). The Solsensor unit has to be fixed on the plane-of-array (POA) for reading the effective irradiance incident on the solar panels.  $I$ - $V$  measurements taken above  $700 \text{ W/m}^2$  POA irradiance have been considered in our analysis as lower values of irradiance introduce significant uncertainty in the translated characteristics.

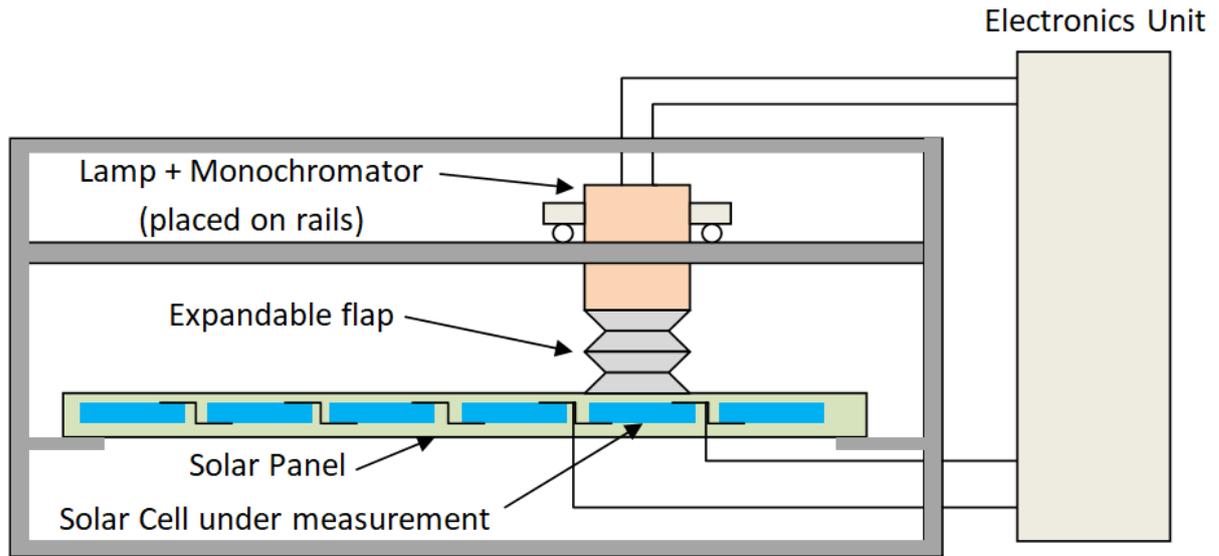
Fig. 3.3: Schematic diagram of QE measurement of a cell embedded in a solar panel. The C-M-QE instrument is located at the Photovoltaic Reliability Laboratory at Arizona State University.

External quantum efficiency measurements have been performed on individual cells in degraded PV modules for understanding the impact of material degradation (discoloration and delamination) on the electrical performance of cells embedded in PV modules. For this purpose, a module level quantum efficiency instrument (make: PV Measurements, model: C-M-QE) has been used during my internship at Arizona State University. This QE system uses a broadband light source (Xenon arc lamp [96]), the light from which is passed through a chopper and a monochromator, thereby generating a monochromatic (single wavelength) beam pulsating at a specific frequency which is directed towards the device under test. This instrument has the provision of measuring the cell QE from the module terminals for which it uses a white bias light on the surrounding cells, to keep them forward biased and conducting. However, since we studied old discolored modules, we had cut the back-sheet of the modules at some spots to access the solar cell terminals, and we performed direct QE measurement of the solar cell by accessing its cell interconnects. The schematic diagram for the measurement of external quantum efficiency of a cell inside a solar panel is shown in Fig. 3.3.

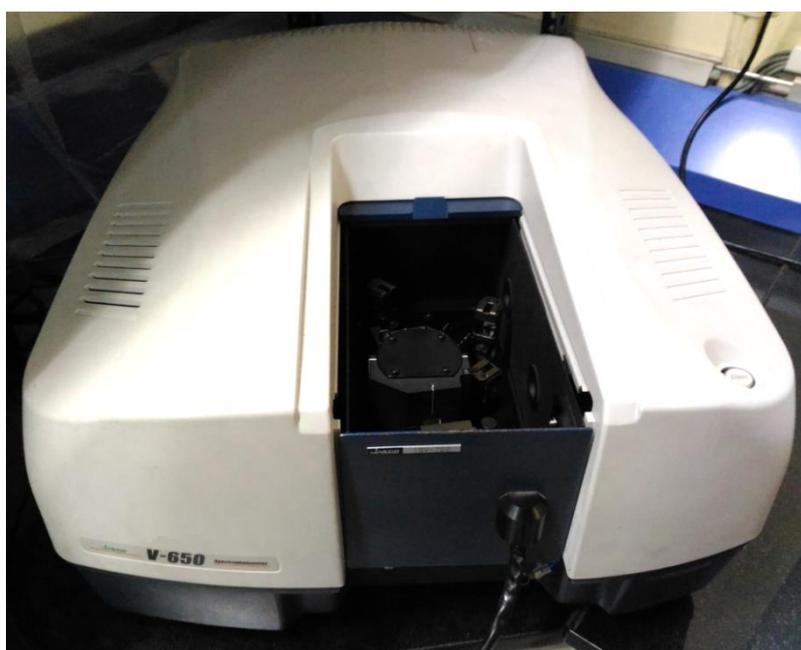
Fig. 3.4: UV-Vis spectrometer with integrating sphere – (a) schematic diagram, and (b) photograph of the Jasco V-650 spectrometer at IIT Bombay.

The UV-Visible spectra in transmittance and reflectance modes can provide important information about the material's optical properties. The transmittance of the top glass and encapsulant layer in the visible region is an important parameter that determines the performance of the PV module. We have used the Jasco V-650 spectrometer [97] (shown in Fig. 3.4) to measure the UV-Vis transmittance (of 2 cm x 2 cm coupons) in the range of 200 nm to 900 nm. This spectrometer is equipped with two different lamps – (i) Deuterium lamp (for use in 190 – 350 nm range) and (ii) Halogen lamp (for use in 330 – 900 nm range). The wavelength accuracy of this instrument is  $\pm 0.2$  nm, and the photometric accuracy is  $\pm 0.3$  % Transmittance. This spectrometer is used with an integrating sphere accessory, and the calibration of the instrument is done using a white reflectance standard coated with Barium Sulphate.

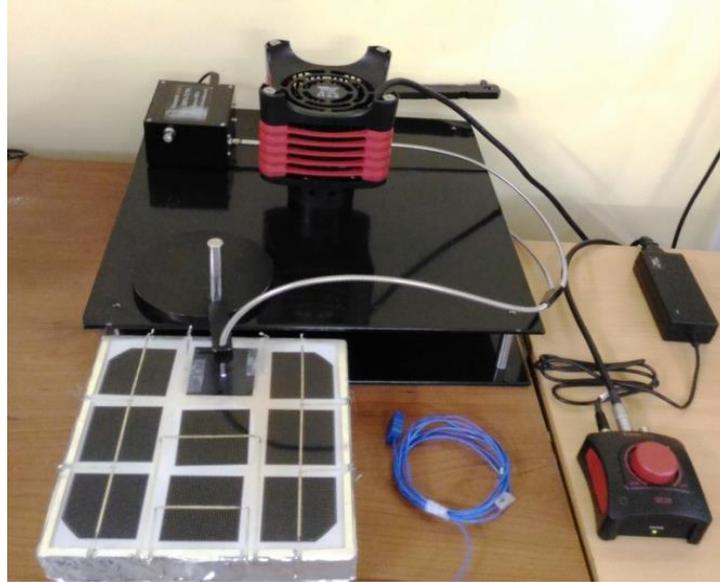
Fig. 3.5: Measurement of fluorescence spectra using fiber optics spectrometer – (a) schematic diagram, and (b) photograph of the setup at IIT Bombay. Thorlabs SOLIS 365C UV light source is combined with fiber optics spectrometer for this measurement.

The fluorescence spectra have been measured in accelerated test samples using a 365 nm UV light source (make: Thorlabs, model: SOLIS 365C [98]) and a Silicon detector based fiber-optics spectrometer (make: Research-India, model: RISC [99]). The setup is shown in Fig. 3.5. The UV light source is placed on top of a collimating lens that focuses the UV light on to a fiber optics cable. This UV light is carried to the sample, and the emitted fluorescence light is picked up by a separate set of fiber optics cable (located at the periphery of the probe tip). The captured light is carried over to the detector unit, where a suitable grating is used to split the incoming light into different wavelength regions, and is then directed onto the detector. Before each measurement, the UV light intensity is calibrated by using a white reflectance standard (made of PTFE) at 25000 counts (with integration time of 1 ms). This ensured that the fluorescence intensity could be compared between multiple measurements after different exposure hours. The fluorescence of the actual samples were captured at integration time of 200 ms with boxcar set at 3 and average of 30 samples was taken for each measurement.

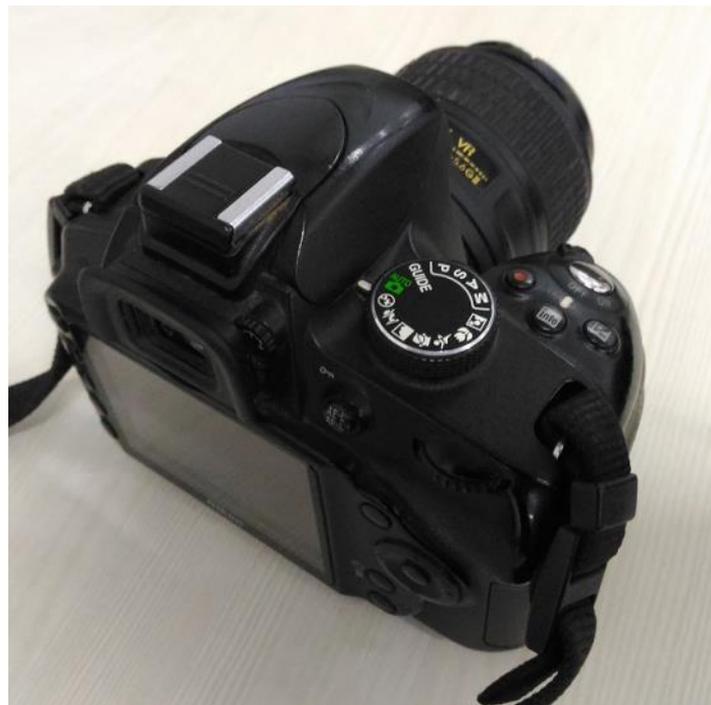
Fig. 3.8: Digital camera (Nikon D5300) used for visual (RGB) photography (at IIT Bombay). This camera is also used for capturing fluorescence images.

CMOS detector-based Digital Single Lens Reflex (DSLR) camera (make: Nikon, model: D3200 [100]) has been used in our All-India field surveys for taking visual pictures of the PV modules. Images were taken such that the whole panel comes in the field of view and the module appears as close to rectangular as possible, given the site-specific constraints. Since the objective is to determine the color of the module from the image (through image processing techniques), images taken above  $700 \text{ W/m}^2$  irradiance have been used for processing (as low light conditions can significantly impact the color reproduction in the captured image). The images have been captured in RAW format and these images are later converted to TIFF format for further processing. The camera has been shown in Fig. 3.8.

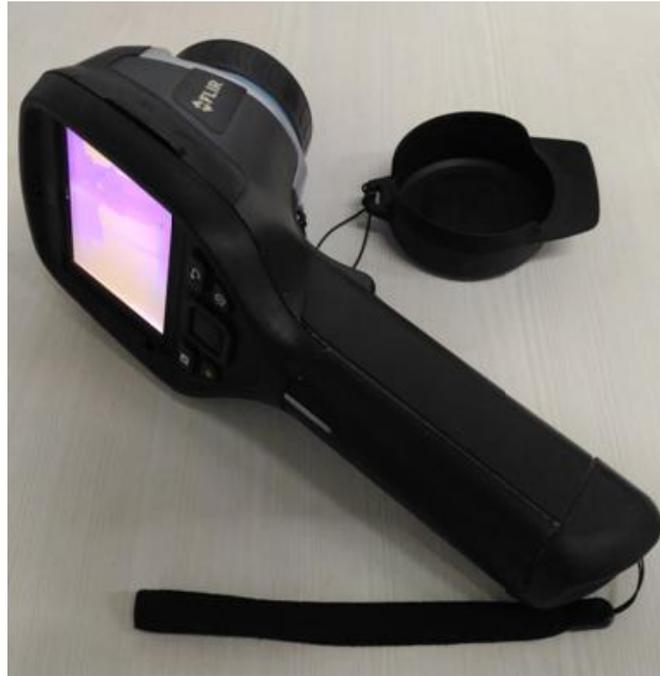
Fig. 3.9: Thermography of solar panels – (a) schematic diagram (angle of view as per recommendation of Kontges *et al.* [43]), and (b) FLIR camera (model E60) used for IR imaging of PV modules.

Infrared thermography is a contactless temperature measurement technique widely applied in industry for measuring the temperature of the PV modules in the field. FLIR E60 [102] camera, having 320 x 240 pixel resolution, was used for taking the IR images in the field. This instrument uses an un-cooled micro-bolometer for sensing the temperature based on infrared energy emitted by the test device. It has a temperature sensitivity of  $< 0.05$  K, and its temperature accuracy is  $\pm 2$  °C (if correct emissivity of surface is chosen). The IR images of crystalline silicon PV modules have been taken from the backside. All the IR images were taken under high irradiance condition (plane-of-array irradiance  $> 700$  W/m<sup>2</sup>). The emissivity setting of the IR camera was set to 0.95 when taking the images from backside (imaging the backsheet) whereas emissivity was set to 0.85 for the glass side, as per [43]. The angle of IR camera,  $\phi$ , is maintained within the limits of angle of view as indicated in Fig. 3.9(a).

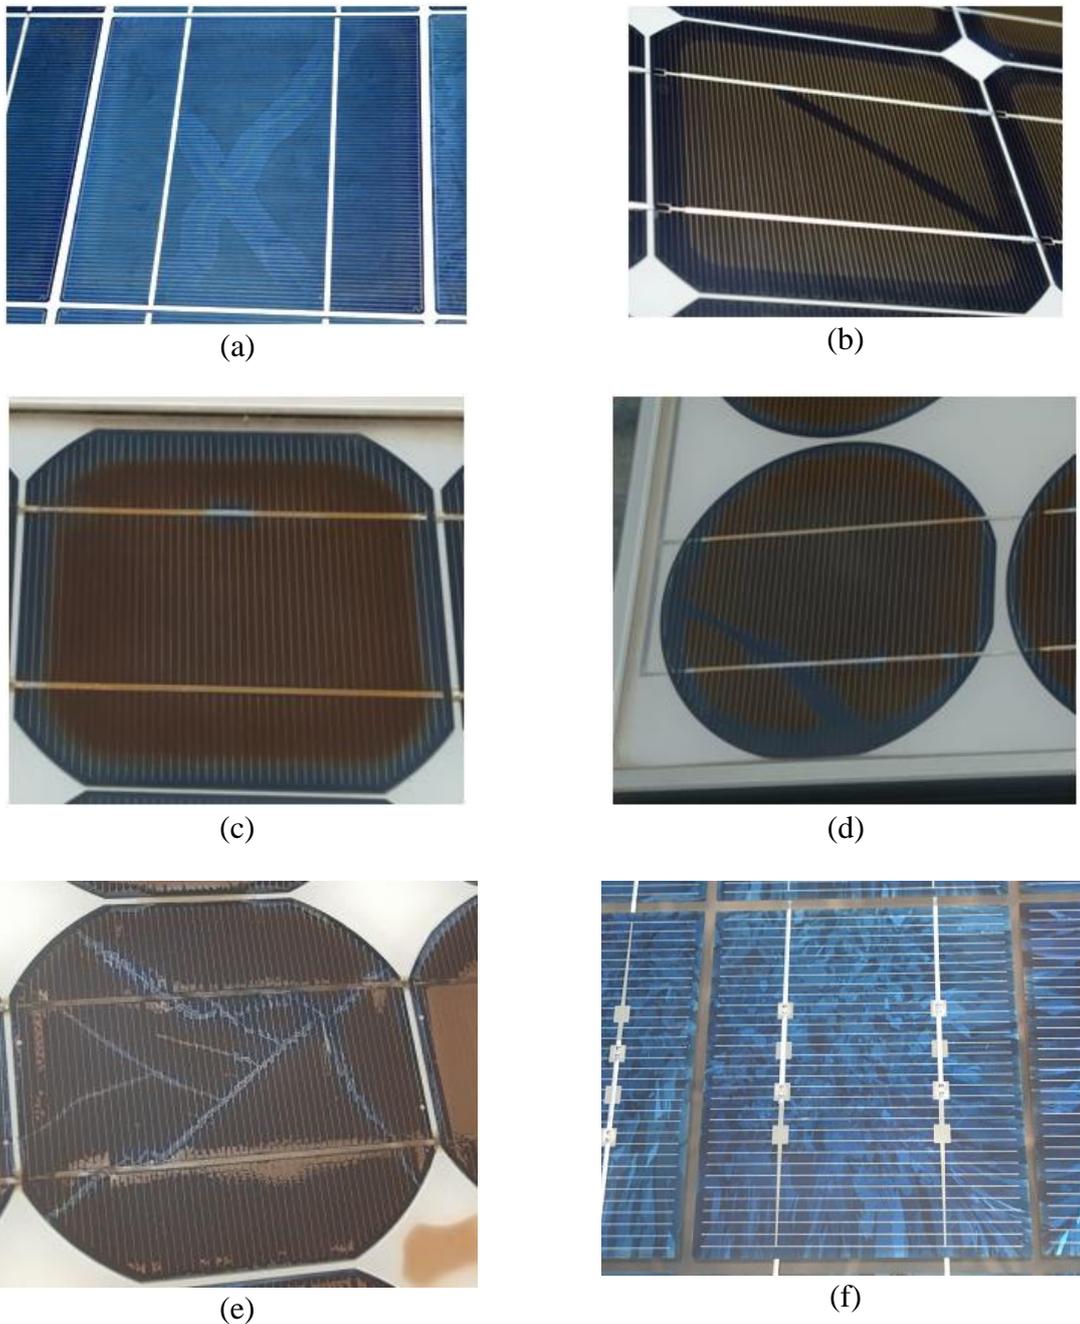
Fig. 4.2: Examples of encapsulant discoloration observed during the surveys – (a) discoloration in a 3 year old module in Hot & Dry zone (with photo-bleaching effect along crack in center of cell), (b) discoloration in a 8 year old module in Warm & Humid zone (with snail track formation along crack), (c) discoloration in a 18 year old module in Warm & Humid zone (with crack induced photo-bleaching near the busbar), (d) discoloration in a 18 year old module in Cold & Sunny climate (with crack induced photo-bleaching), (e) discoloration in a 20 year old module with photo-bleaching and delamination along cracks, and (f) solar cells in a 27 year old glass-glass module in Hot zone showing no signs of discoloration [20, 21].

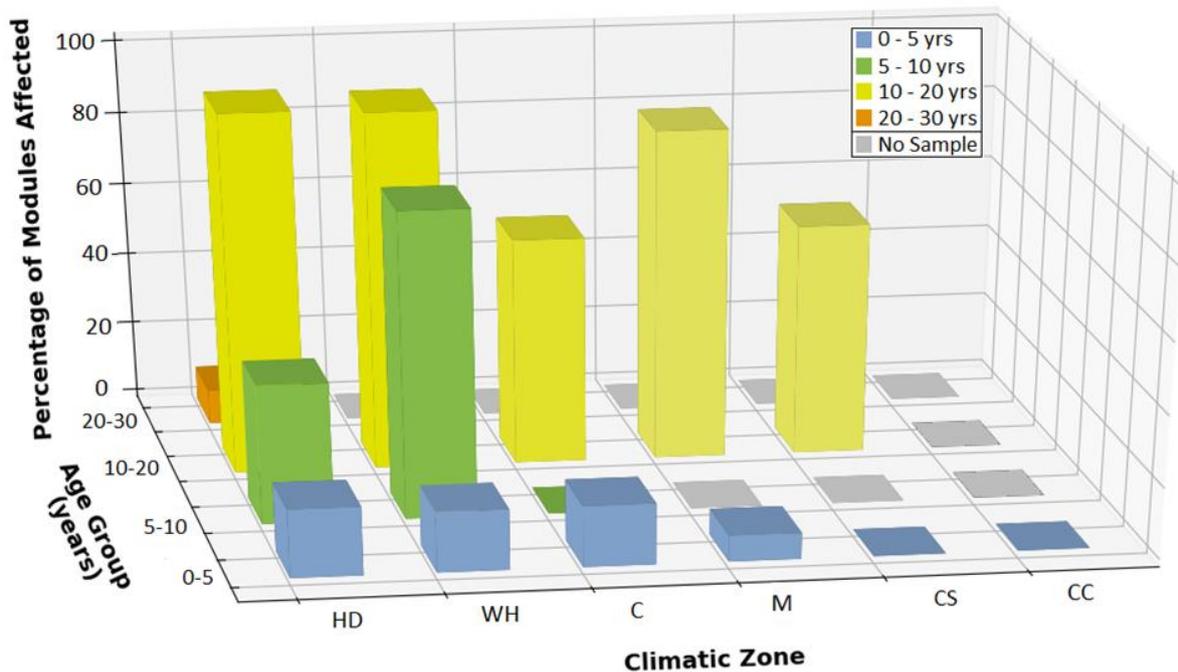
Fig. 4.3: Percentage of modules affected by encapsulant discoloration in different age groups and climatic zones (HD: Hot & Dry, WH: Warm & Humid, C: Composite, M: Moderate, CS: Cold & Sunny, CC: Cold & Cloudy). The data has been colour-coded based on the age of the panels, and groups with no sample data have been marked with grey colour.

The percentage of affected panels rises rapidly in the Warm & Humid (WH) zone as the panel age increases (as shown in Fig. 4.3), which hints that this zone is very severe for the encapsulant. Double glass crystalline silicon modules were inspected only at two sites (in the same area/locality) in our surveys (total 52 samples in two surveys), and interestingly these modules did not show any significant discoloration even after 27 years of operation. Hence, the percentage of modules affected is low in the “20+ years” category in Fig. 4.3 (represented by the orange bar). This leads us to suspect that the encapsulant used may not be EVA, but some other high-grade alternative (like silicone). Alternatively, it has also been reported that Cerium containing glass used in the older generation panels could prevent UV rays from passing into the module, thereby preventing discoloration of the EVA [48].

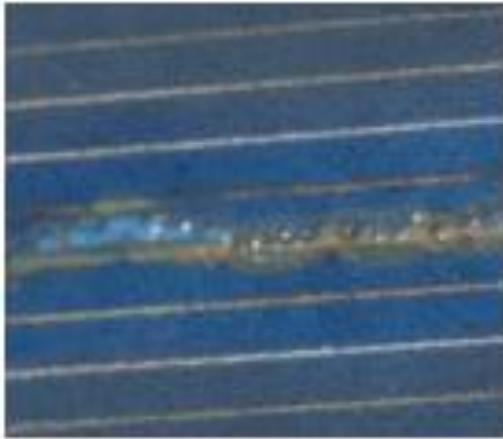
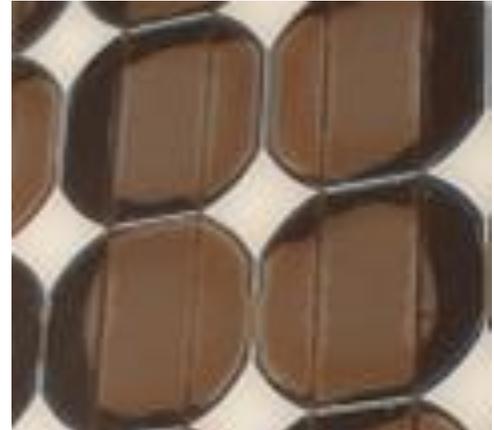
Fig. 4.4: Examples of delamination observed during the survey – (a) along snail track, (b) along fingers at cell edge, (c) near the busbar, (d) on top of solar cell in an old glass-glass module, (e) close to the center of a cell in a young module in Non-Hot climate, and (f) in multiple cells in an old module in Hot climate [20, 21].

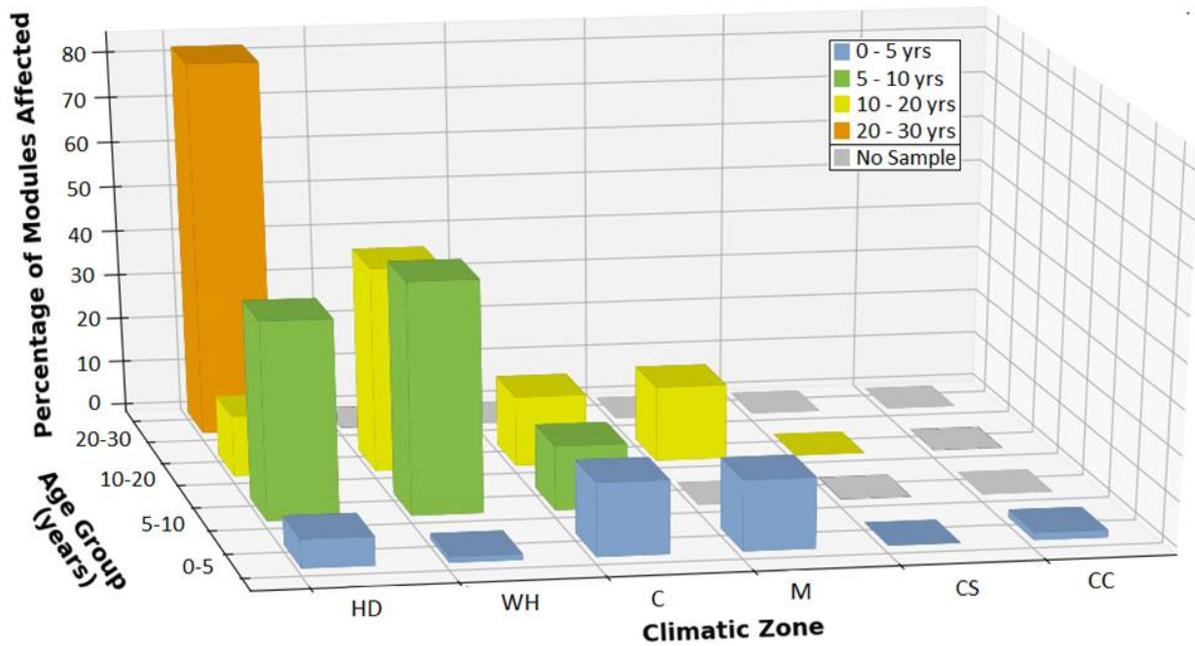
Fig. 4.5: Percentage of modules affected by front-side delamination in different climatic zones and age groups (HD: Hot & Dry, WH: Warm & Humid, C: Composite, M: Moderate, CS: Cold & Sunny, CC: Cold & Cloudy). Delamination is observed more in the Hot zone as compared to the Non-Hot zone, in the old age category.

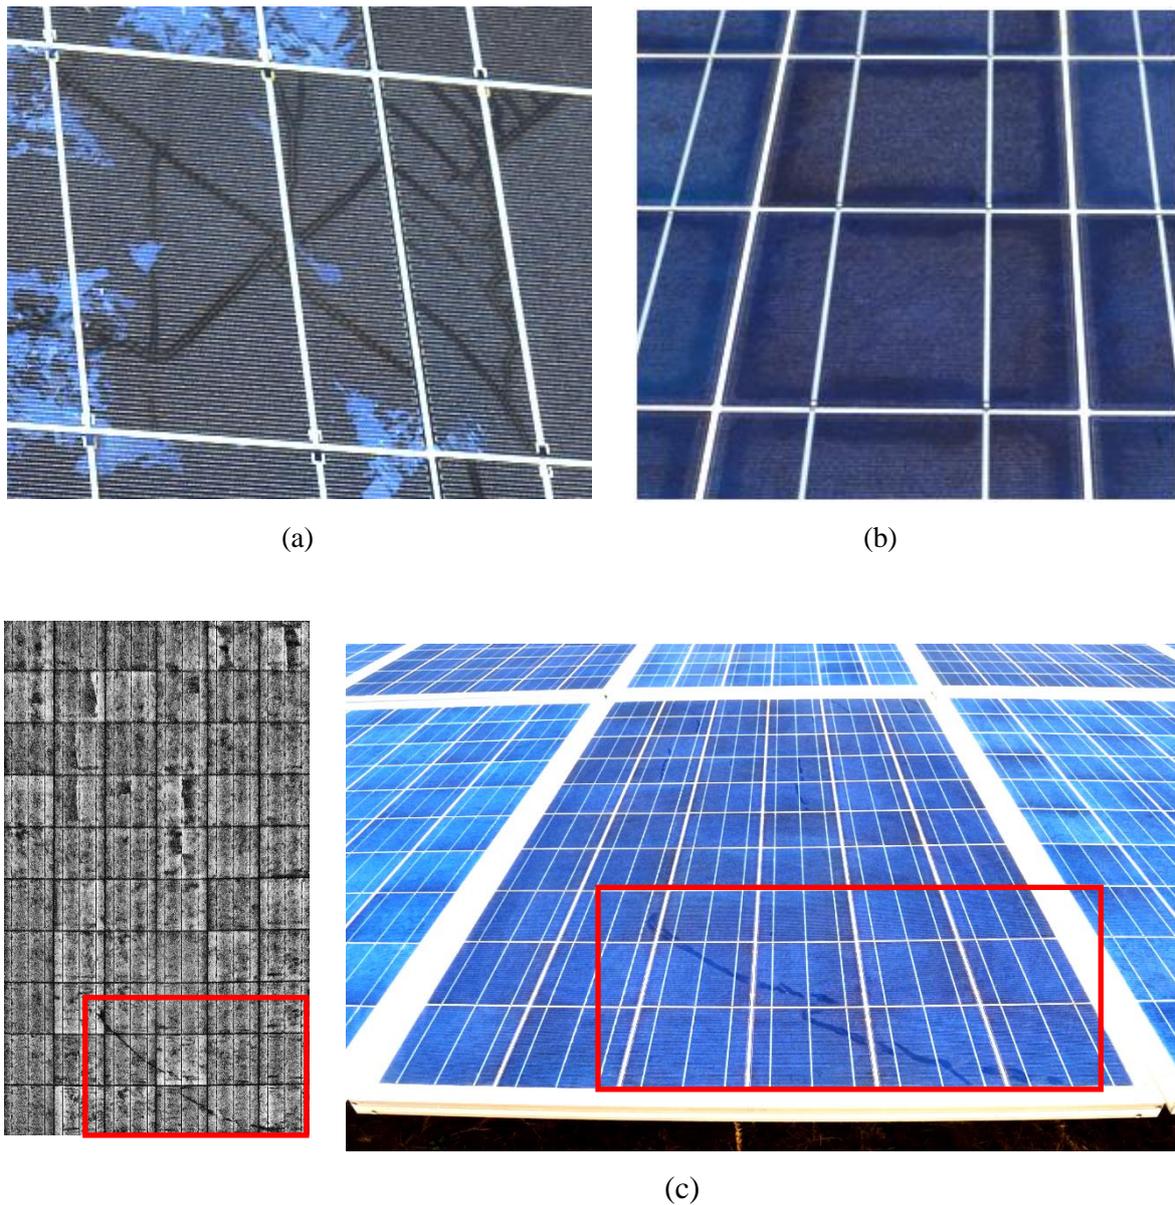
Fig. 4.6: Examples of Snail Tracks observed in the survey – (a) snail track in a young module in Hot & Dry zone, (b) framing type snail track in a young module in Warm & Humid zone, and (c) EL image of a PV module showing crack and the corresponding region in the visual image showing a snail track spanning across multiple solar cells [20, 21].

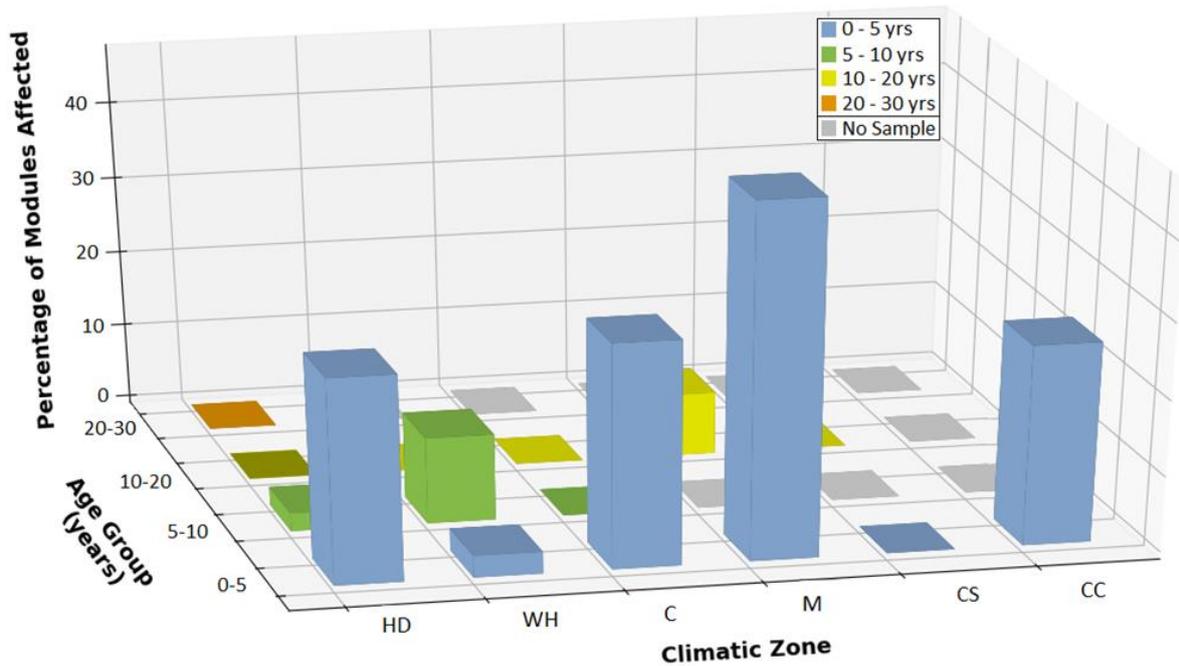
Fig. 4.7: Statistics of non-framing type snail tracks in different climatic zones and age groups (HD: Hot & Dry, WH: Warm & Humid, C: Composite, M: Moderate, CS: Cold & Sunny, CC: Cold & Cloudy).  
Most of the affected panels are in the young age group.

Figure 4.7 shows the statistics of snail tracks in different climatic zones and age groups. It is evident that snail tracks are mostly observed in the young modules and further, the affected modules are widely dispersed in different climatic zones (Hot & Dry, Composite, Moderate, and Cold & Cloudy).

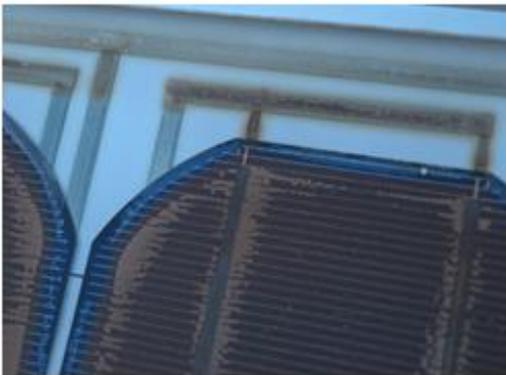
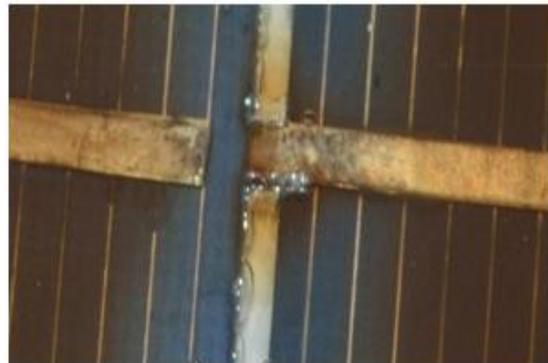
Fig. 4.8: Metallization discoloration on interconnect ribbons observed during the surveys – (a) discoloration patterns in cell interconnects observed in young modules, and (b) corrosion in interconnect ribbons observed in old modules [20, 21].

Metallization refers to the gridlines/fingers, busbars and interconnect ribbons that conduct the charge carriers generated in the solar cells to the electric load, through the junction box attached at the backside of the module. The fingers and busbars are usually made of silver, while the interconnect ribbons are usually of copper, coated with tin. The metallization usually has a shiny silvery appearance but may discolor due to corrosion and also, in some cases, due to improper manufacturing processes (like solder flux deposition on top etc.). Further, discoloration of the encapsulant layer on top of the metallization can also give an impression of discoloration of the underlying metallization. Some examples of metallization discoloration observed during the survey are given in Fig. 4.8.

Figure 4.9 shows the statistics for discoloration of metallization observed during the field survey for ‘All’ inspected modules, grouped on the basis of climatic zone and module age. Some discoloration is observed in the young modules (“0-5 years” category), which is mainly due to non-corrosion issues (like deposition of solder flux, non-uniform tin plating, etc., as shown in Fig. 4.8(a)) whereas in the old modules, corrosion seems to be the main factor responsible for metallization discoloration (representative images shown in Fig. 4.8(b)). Thus, there are

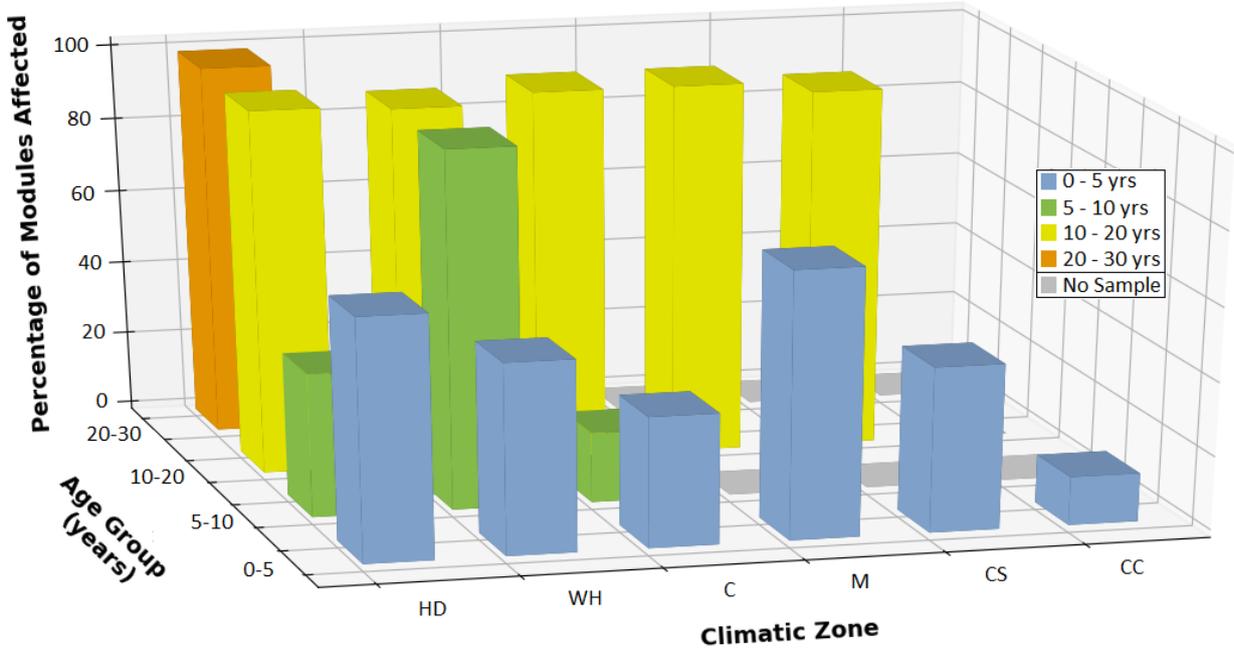
Fig. 4.9: Metallization discoloration statistics in different climatic zones and age groups (HD: Hot & Dry, WH: Warm & Humid, C: Composite, M: Moderate, CS: Cold & Sunny, CC: Cold & Cloudy). Significant discoloration is observed even in the young age group (mostly due to flux deposits and other causes).

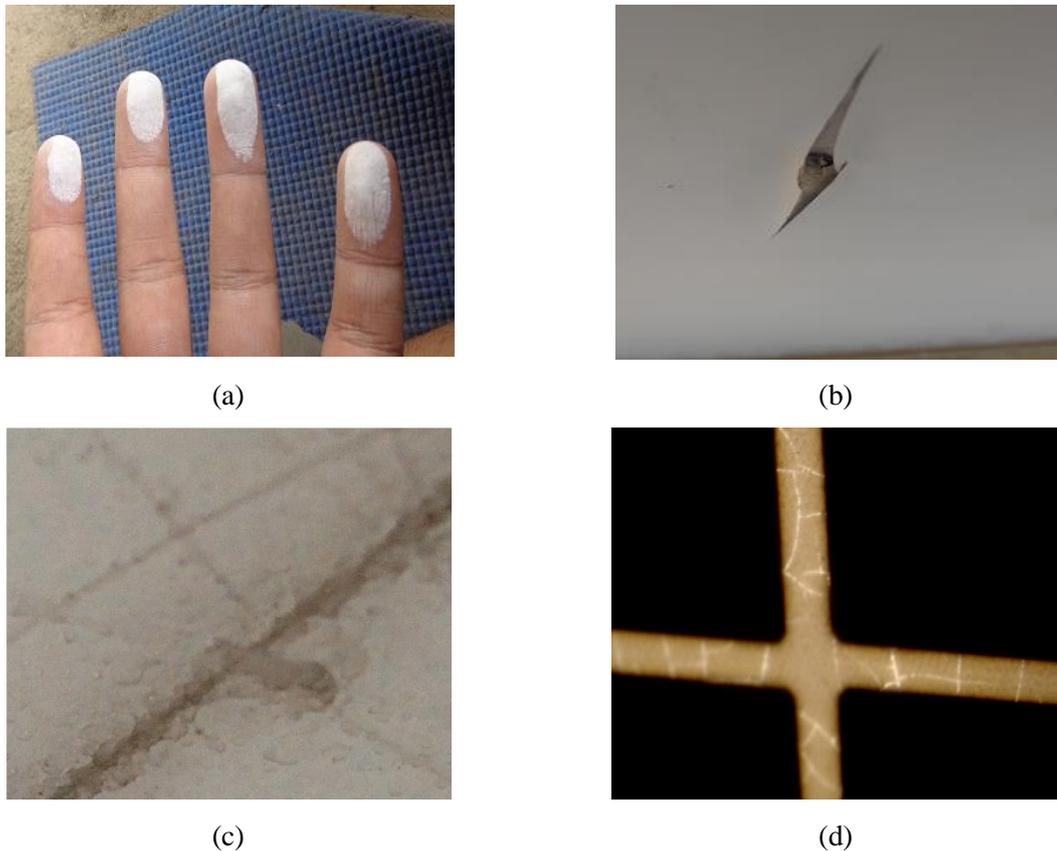
Fig. 4.10: Examples of degradation observed in backsheet – (a) chalking, (b) scratch and delamination, (c) cracks in outer layer of backsheet, (d) cracks in inner layer of the backsheet [20, 21].

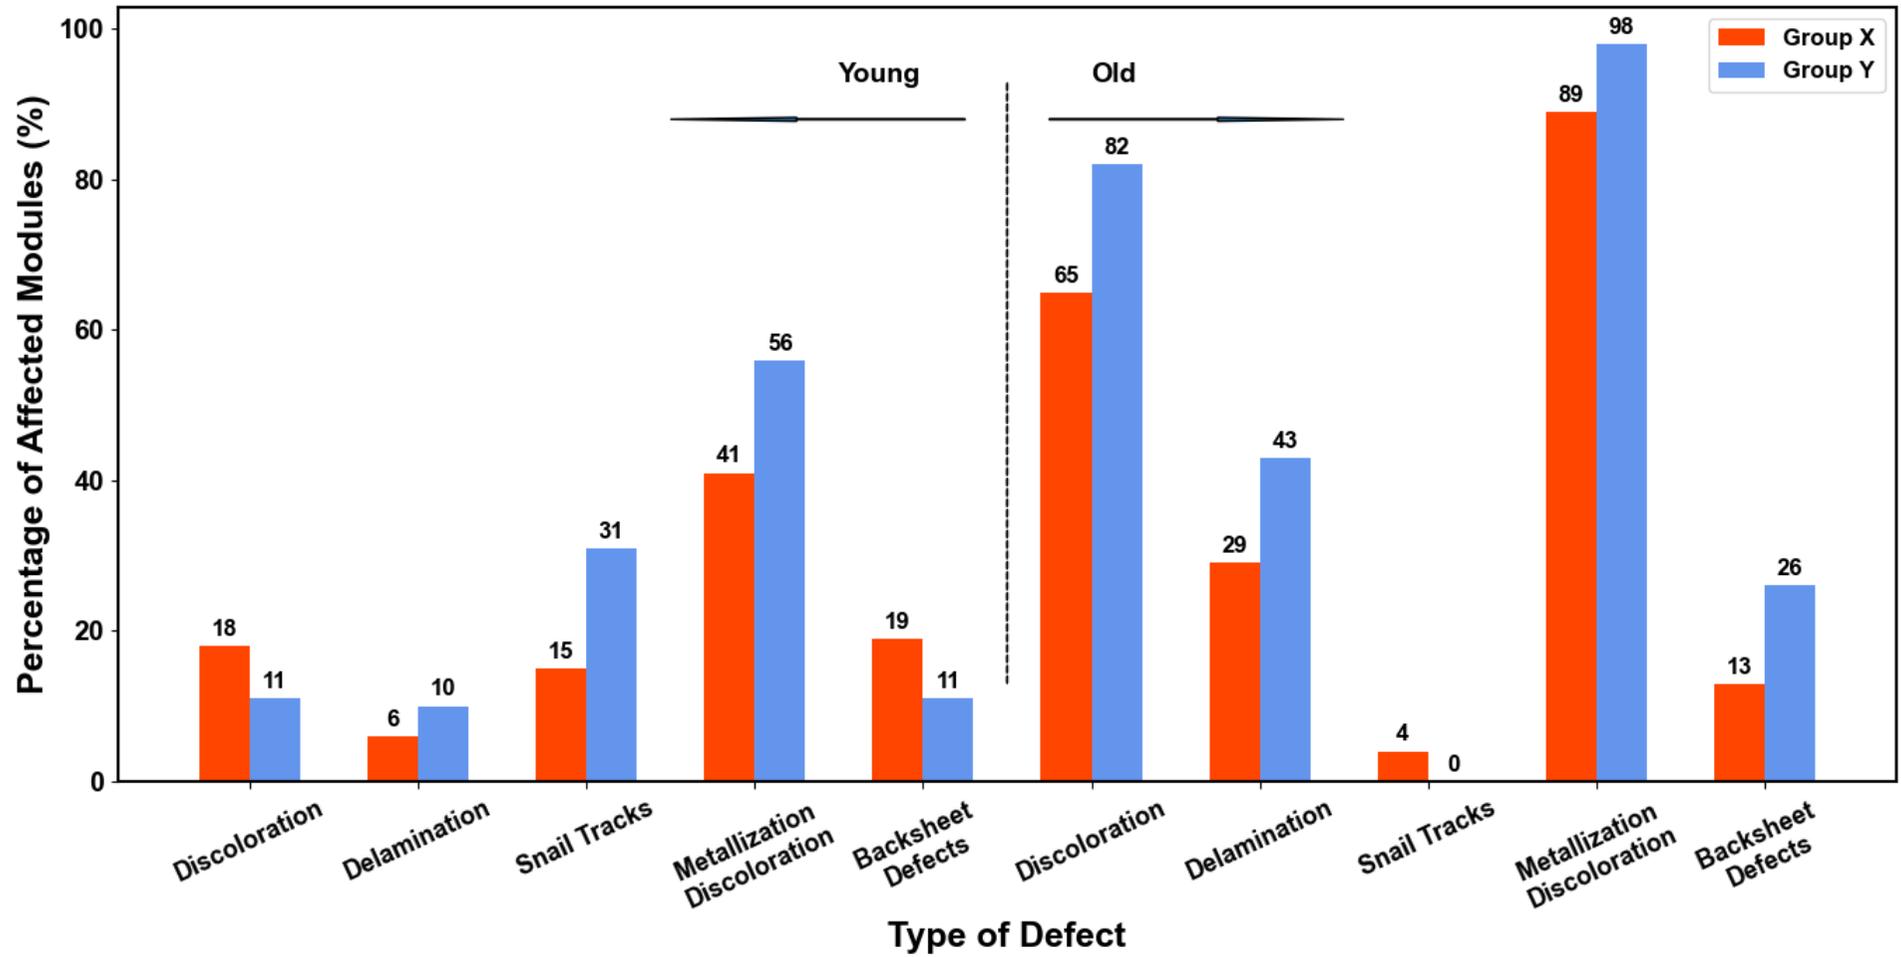
Fig. 4.12: Comparison of the percentage of defective panels in Group X and Group Y sites.

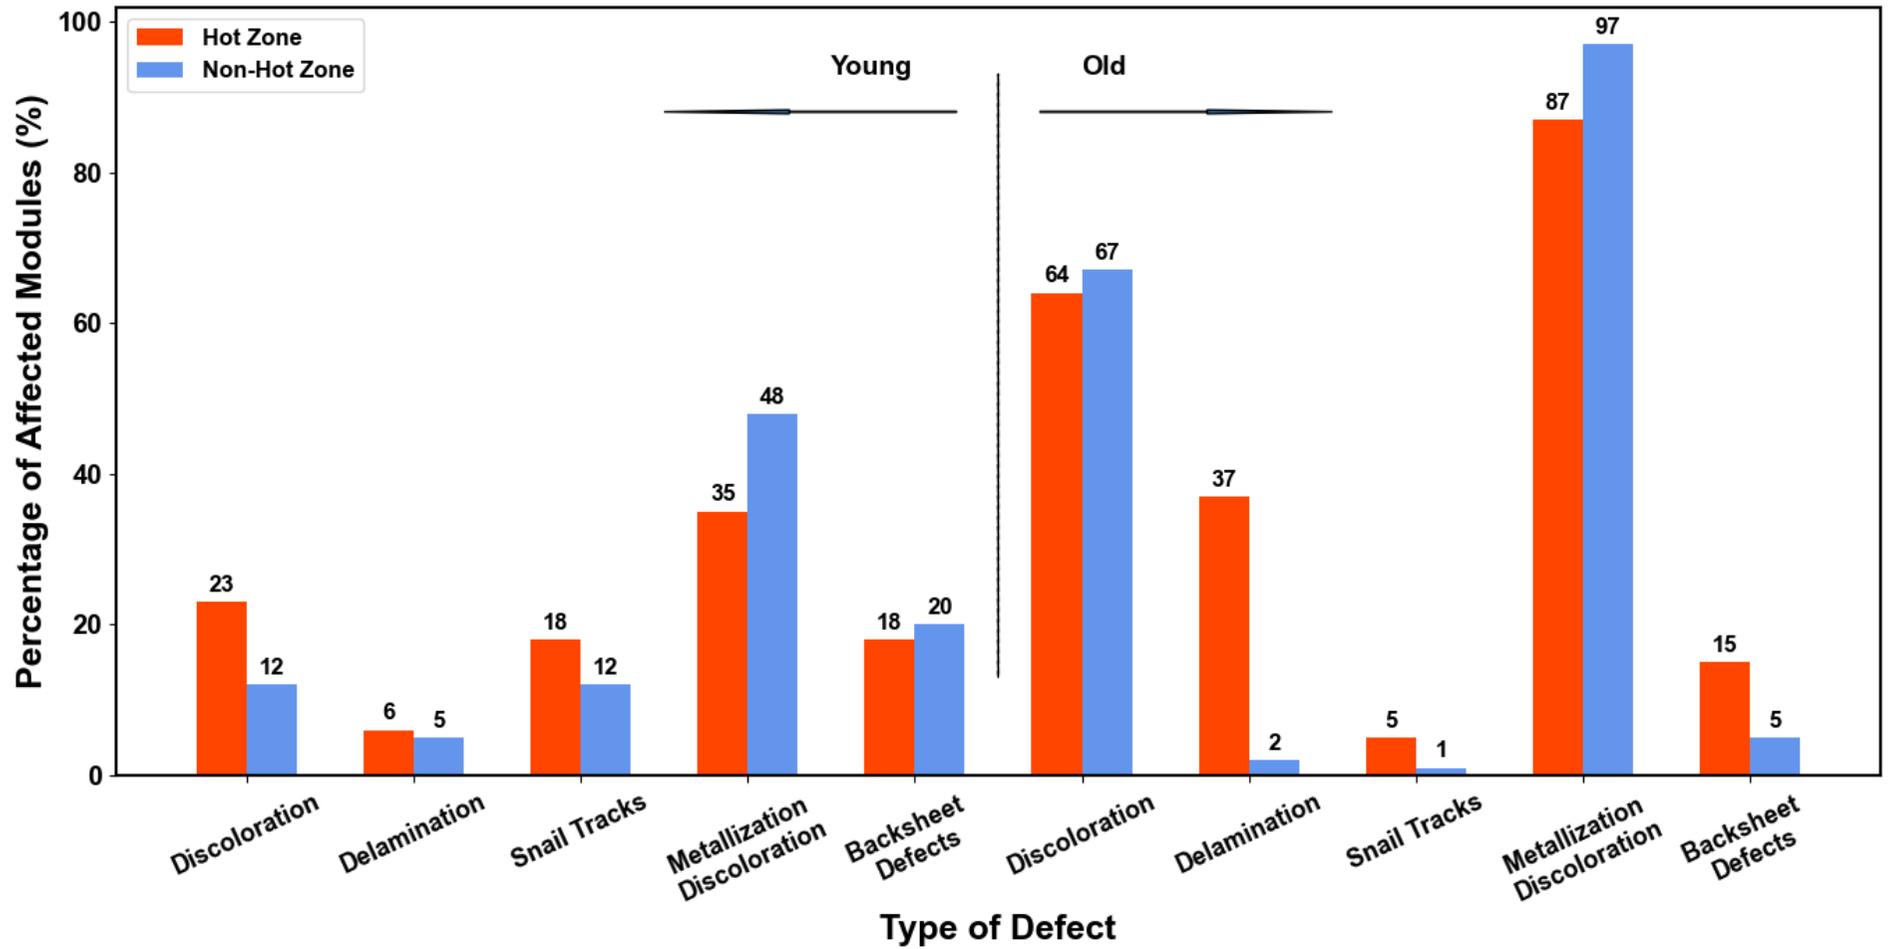
Fig. 4.13: Comparison of the percentage of defective panels in Hot and Non-Hot zones (in Group X sites).

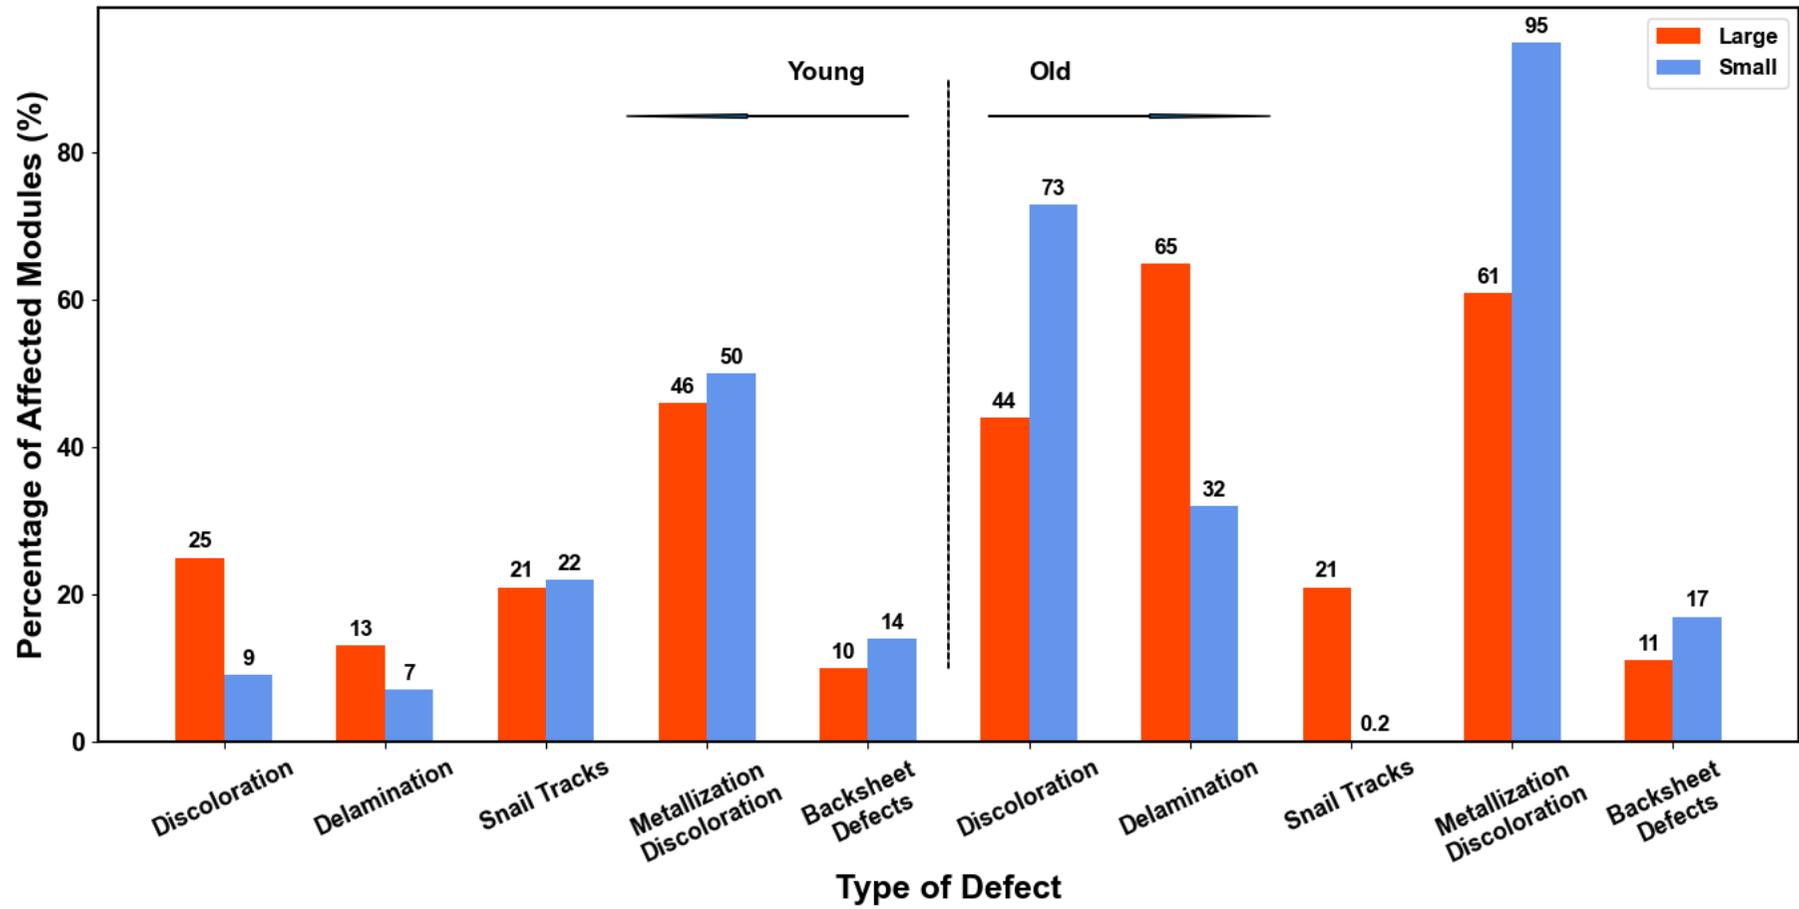
Fig. 4.14: Comparison of the percentage of defective panels in small and large installations.
