# **Encapsulant Discoloration in Photovoltaic Modules in Different Climates of India and its Correlation with Hot Cells and Electrical Degradation**

**Doctor of Philosophy**

**Shashwata Chattopadhyay**

Department of Energy Science and Engineering

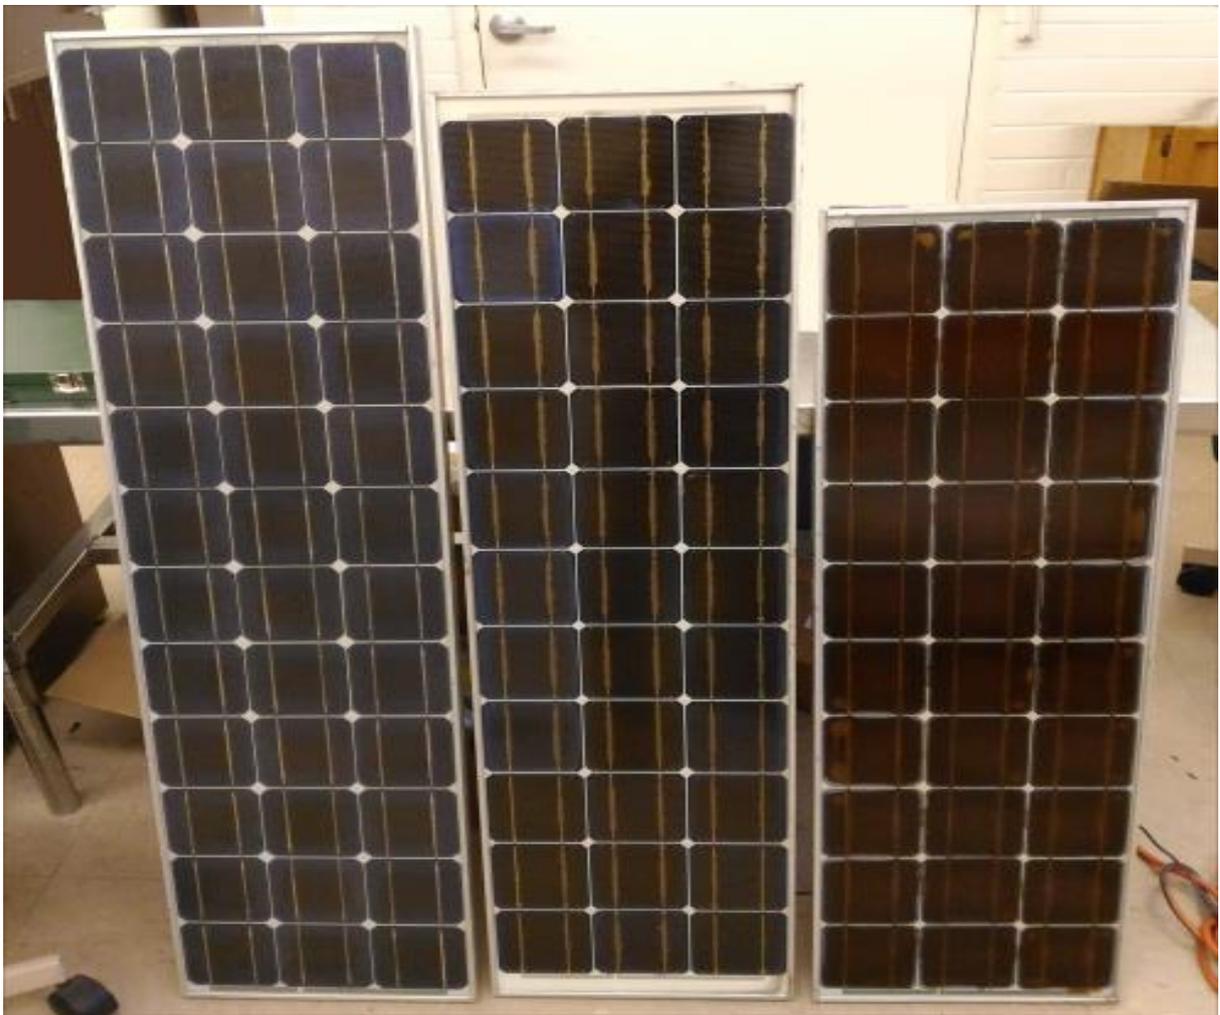
Fig. 5.1: Discolored PV modules used for discoloration study during internship at Arizona State University – Photovoltaic Reliability Laboratory.

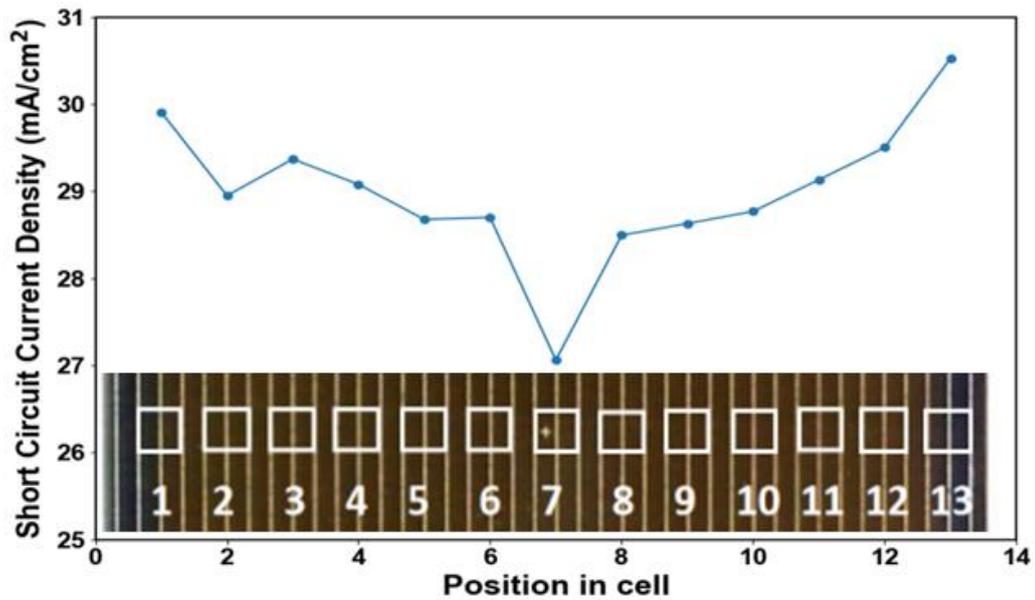
Fig. 5.11: Local short circuit current density (calculated from *EQE* data) at 13 points along the centerline of cell M2. The dip in the center is because of the excess metallization at the center. There is about 7% drop in the current density due to discoloration.

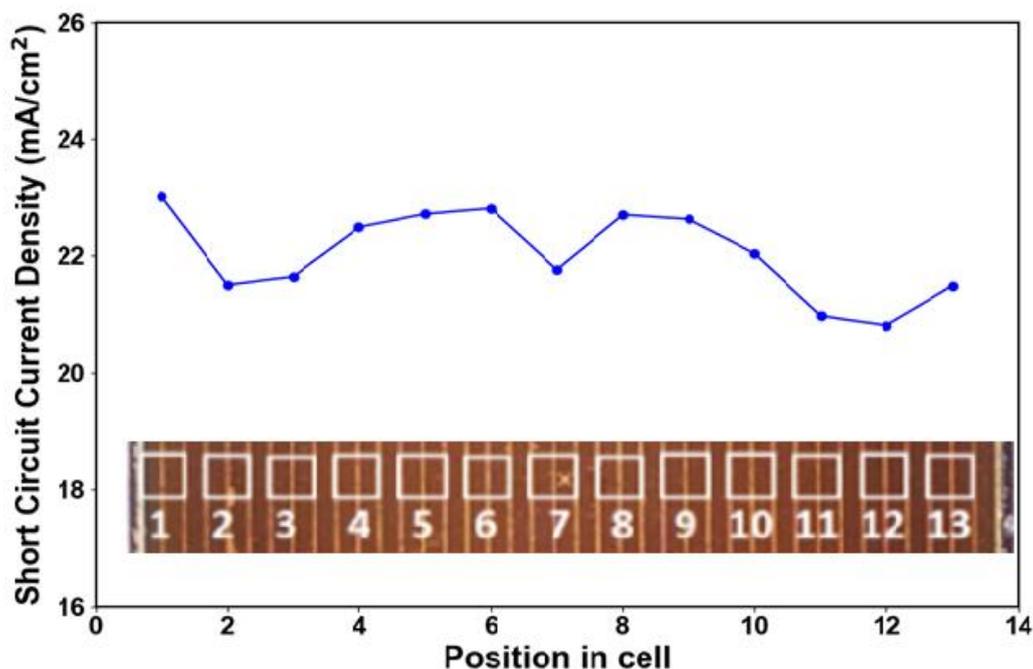
Fig. 5.13: Local short circuit current density (calculated from *EQE* data) at 13 points along the centerline of cell M3. The sharp dip at the center is due to excess metallization (please refer to the visual image). The discoloration is higher close to edge (point 2) than near the center of the cell (point 6).

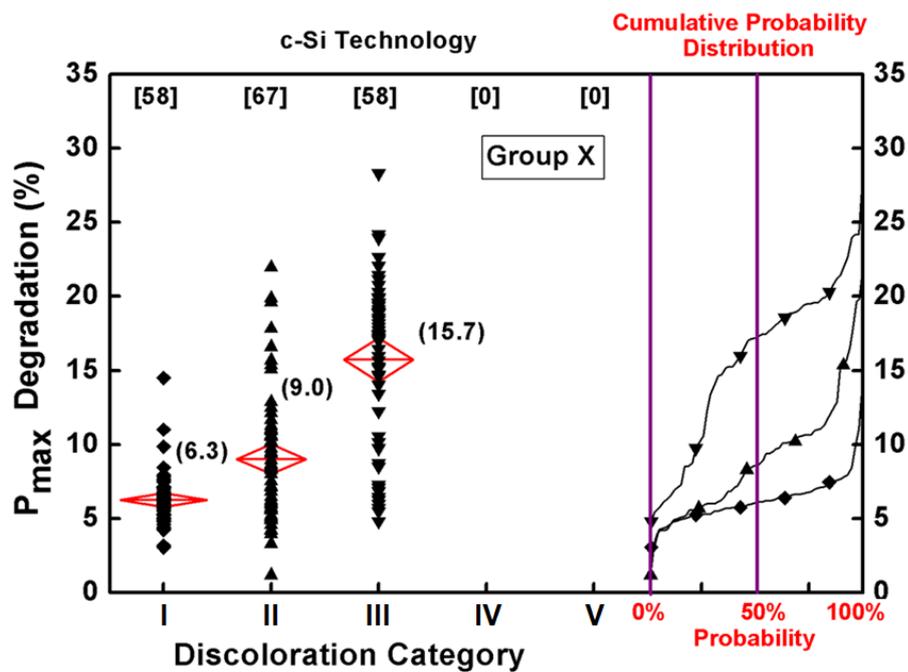
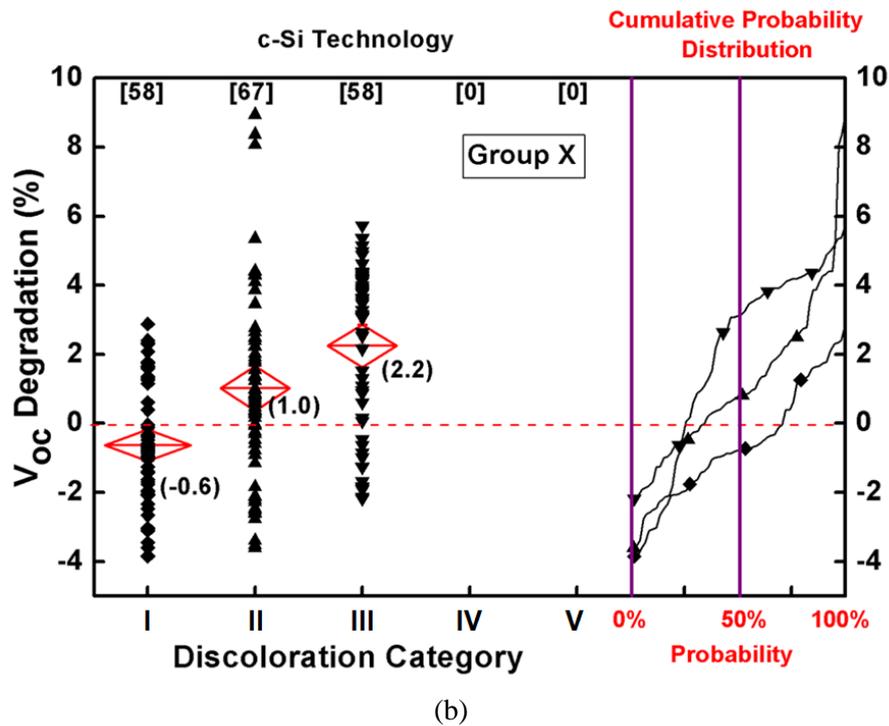
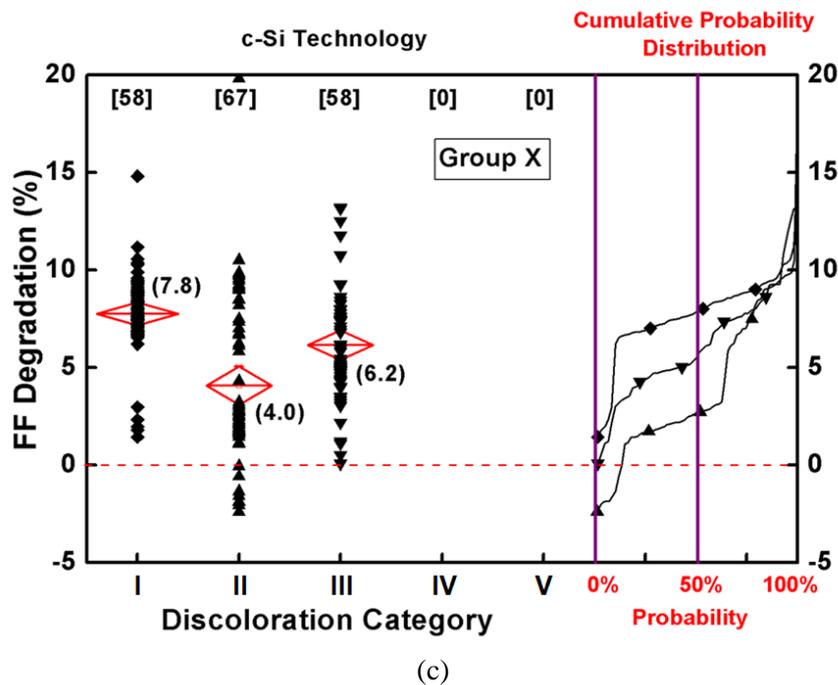
Fig. 5.21: Plot of electrical degradation versus extent of discoloration (discoloration category) for Group X modules - (a)  $P_{max}$  degradation (%), (b)  $V_{oc}$  degradation (%), and (c)  $FF$  degradation (%). The red diamond indicates the 95% confidence interval for the average degradation (average value indicated in brackets). Total number of samples is indicated at the top of each group in square brackets. These graphs are based on 2016 survey data.

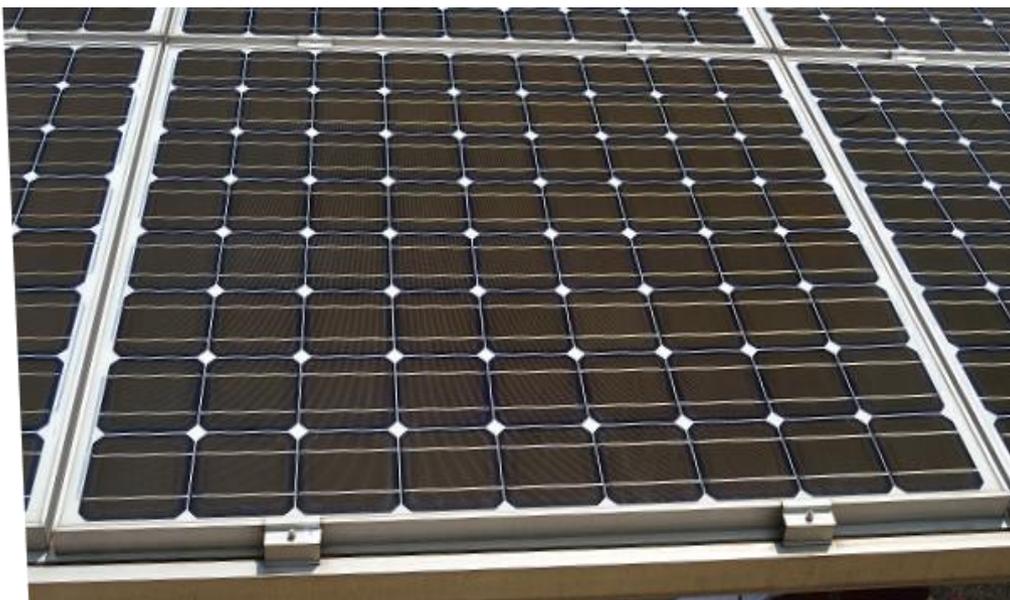
Fig. 6.1: Discoloration over all cells in a PV module.

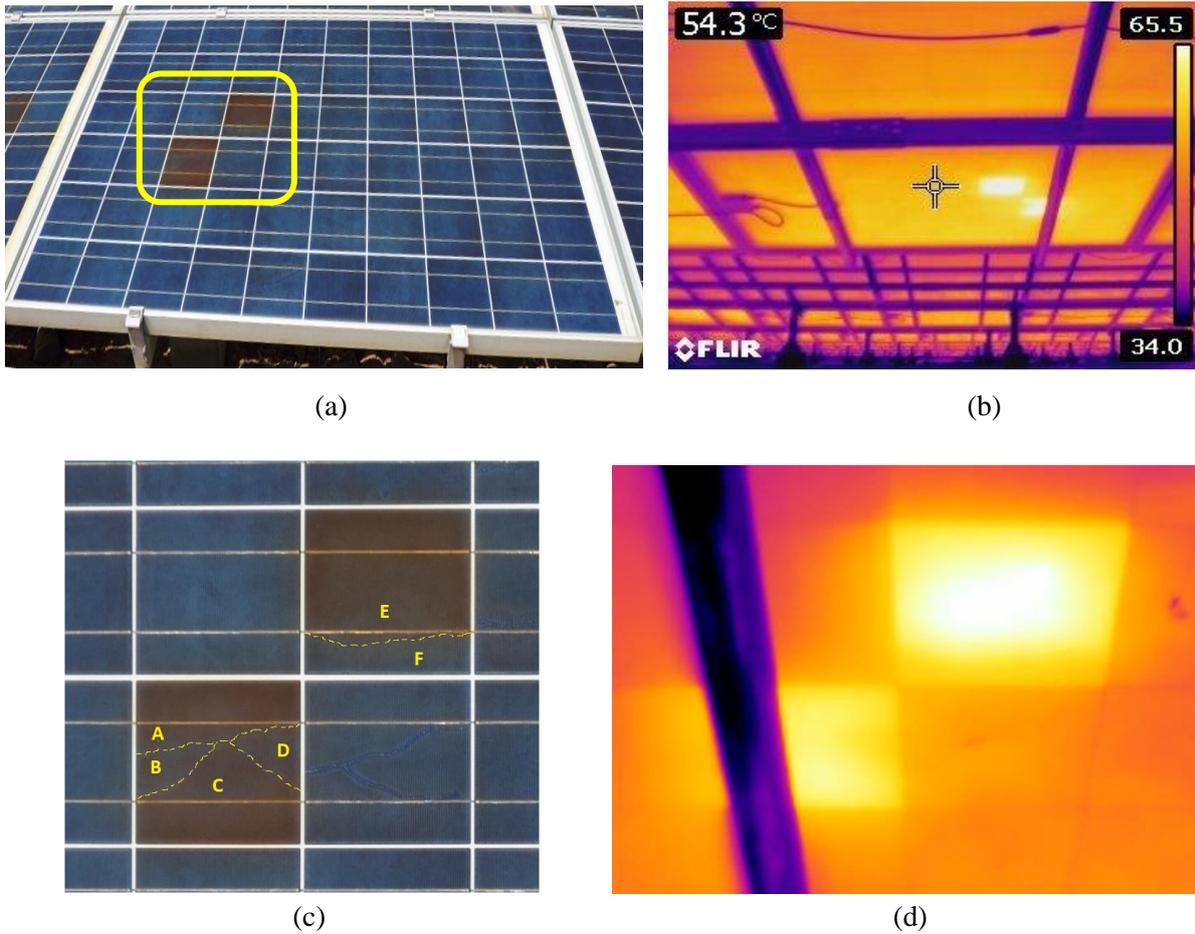
Fig. 6.2: (a) Visual image of a PV module showing localized discoloration of the encapsulant, (b) IR image of the module taken from back-side, (c) zoomed-in visual image of the affected cells (crack lines marked with yellow border), and (d) IR image of the affected area from backside (image is flipped sideways for easy comparison).

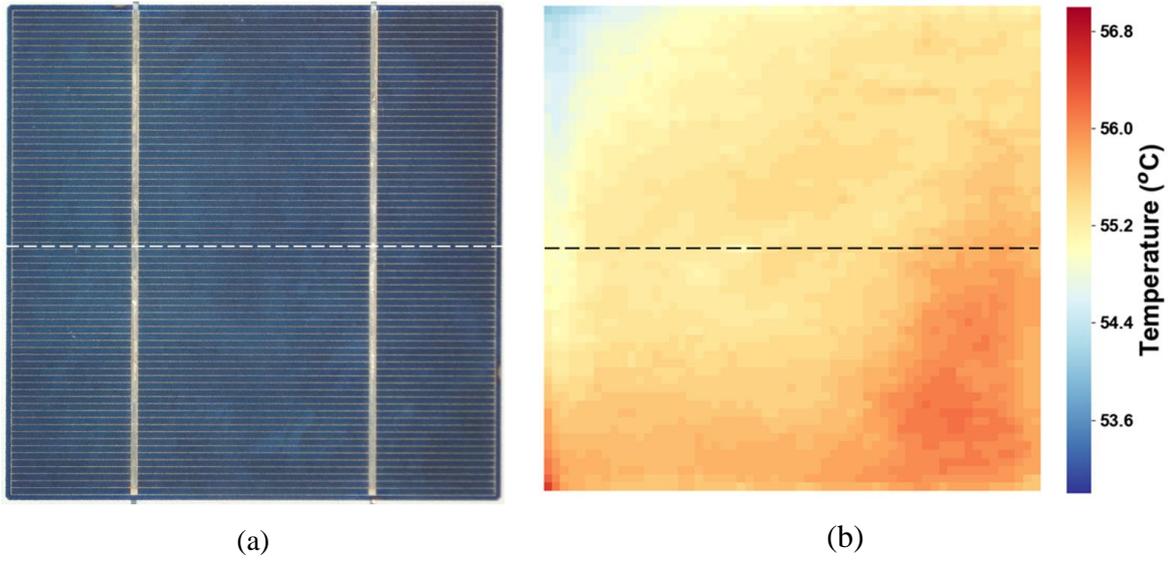
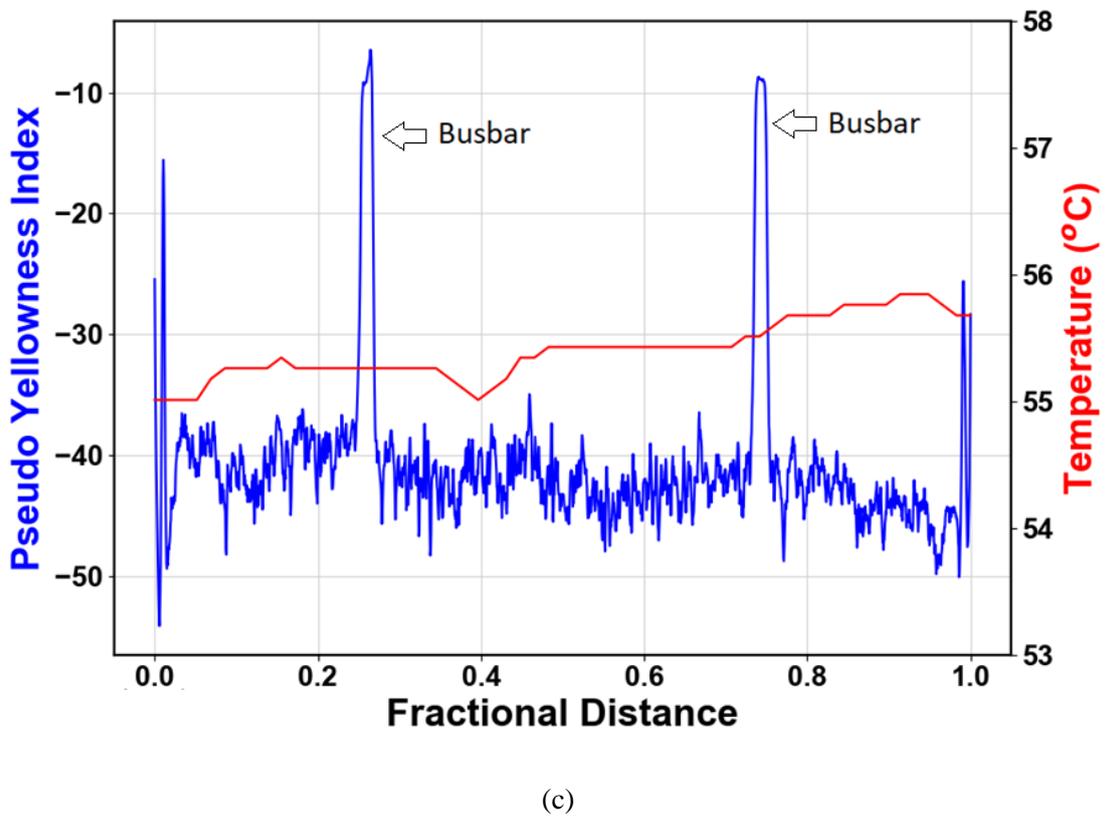
Fig. 6.3: (a) Visual image of a normal temperature solar cell, C1 (after perspective correction), (b) thermal map of the cell (perspective corrected), recorded at Plane-of-array irradiance of  $913 \text{ W/m}^2$ , and (c) variation of the *PYI* and temperature along the centre of the cell (in vertical direction).

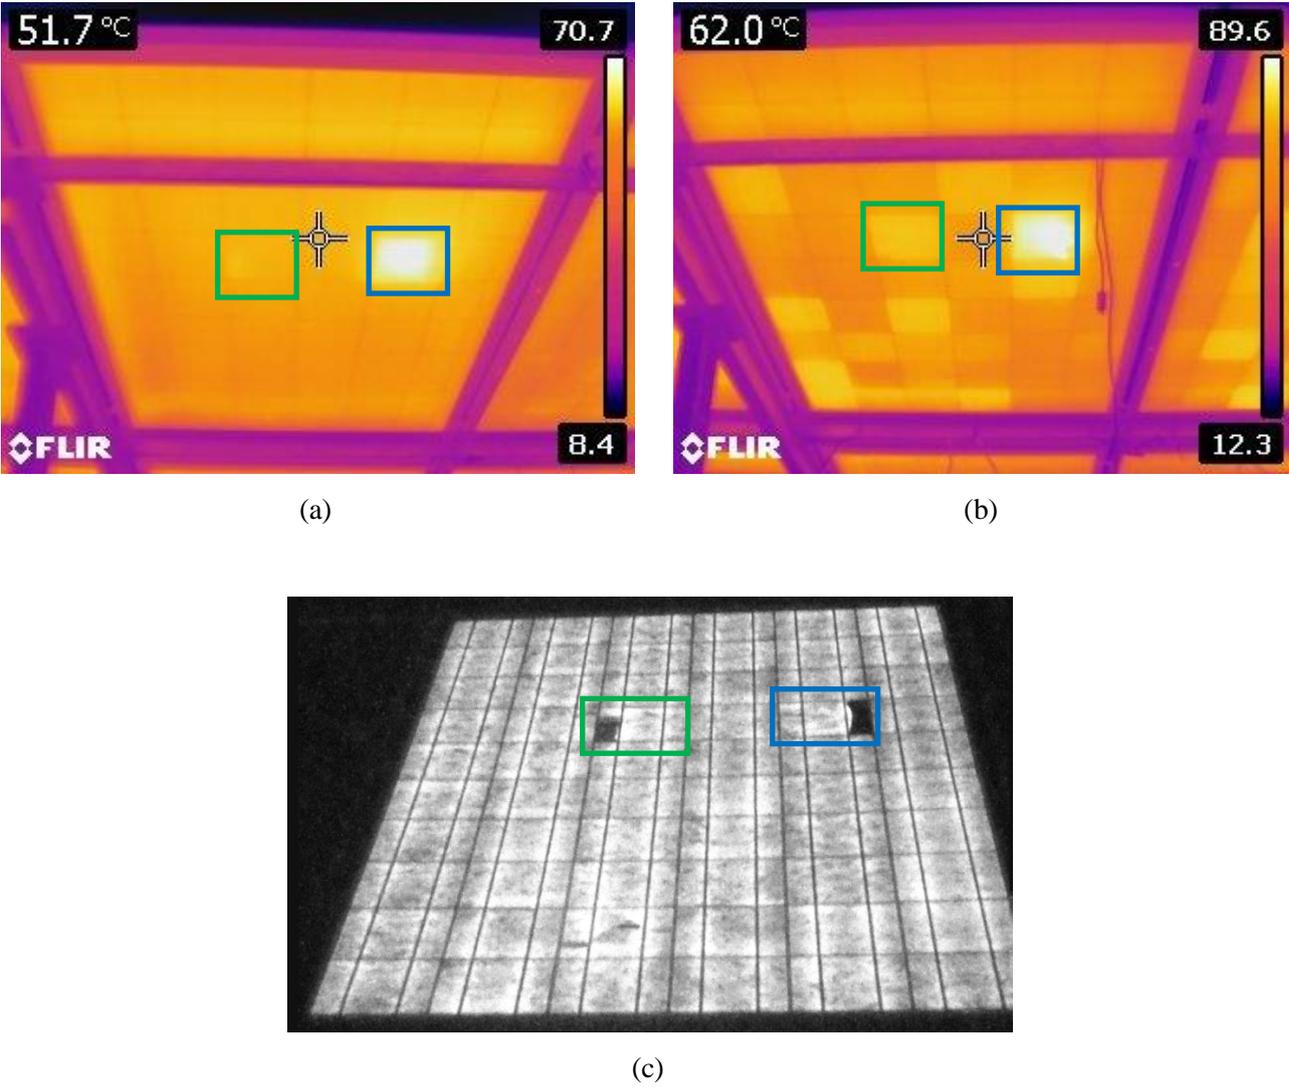
Fig. 6.7: (a) IR image of PV module under MPP condition, (b) IR image of same module under short-circuit condition, and (c) electroluminescence (EL) image of the module showing cracks in cells (the EL image has been flipped sideways to show the correspondence to the IR images which are taken from\_backside). The hot cell is marked in the images by a blue border, and the cracked cell without hot spot is highlighted by green border.

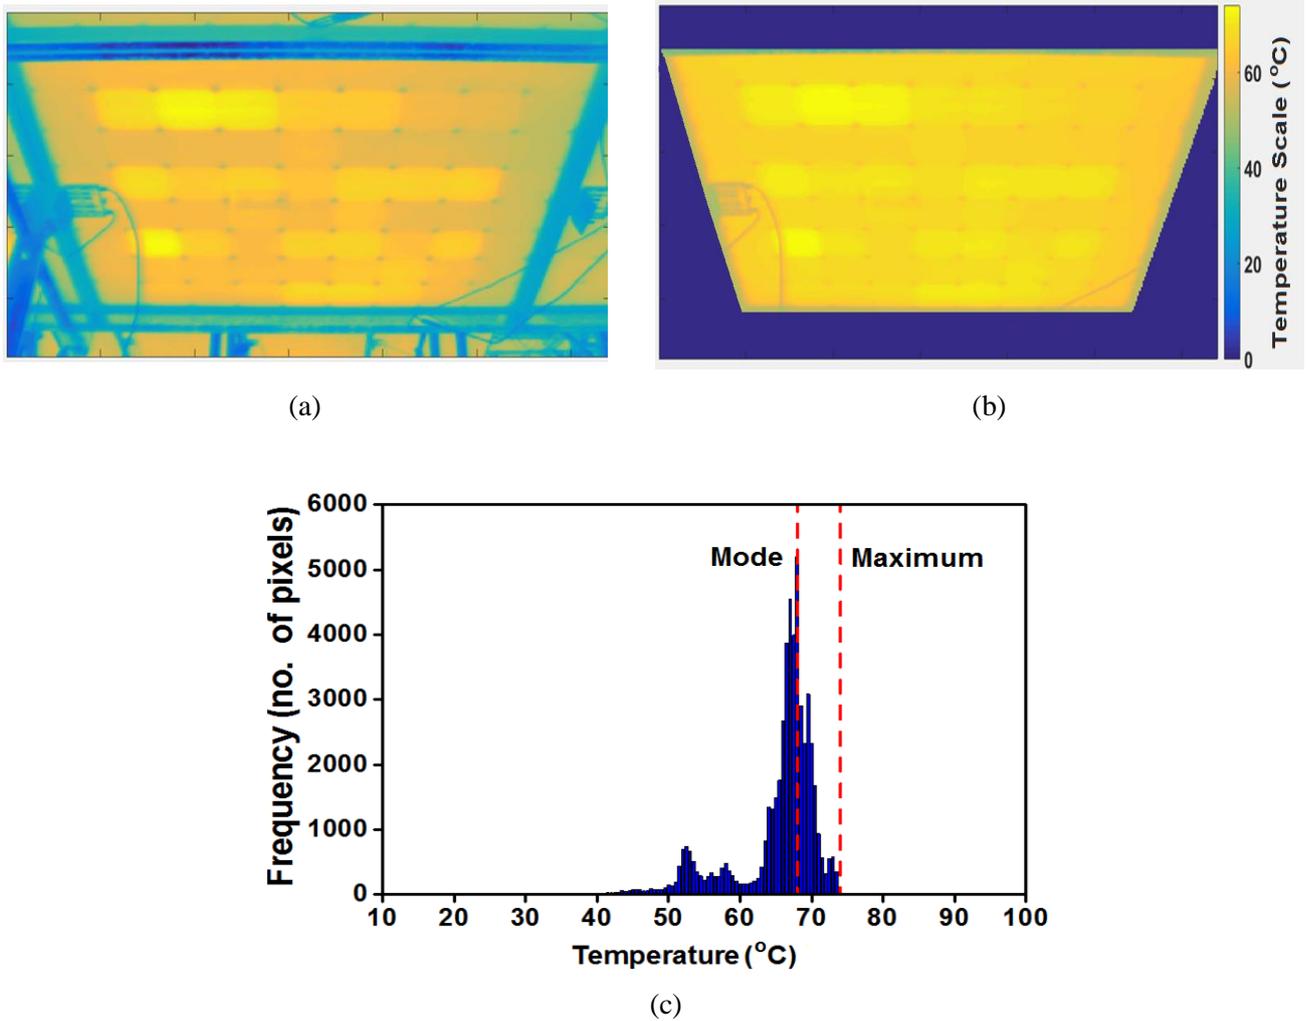
Fig. 6.8: (a) IR image of PV modules in a power plant, (b) region of interest extracted from the IR image, and (c) temperature histogram of the module, showing distinct sections of the module support and ambient (the low temperature humps), and the module backsheet (the high temperature hump).

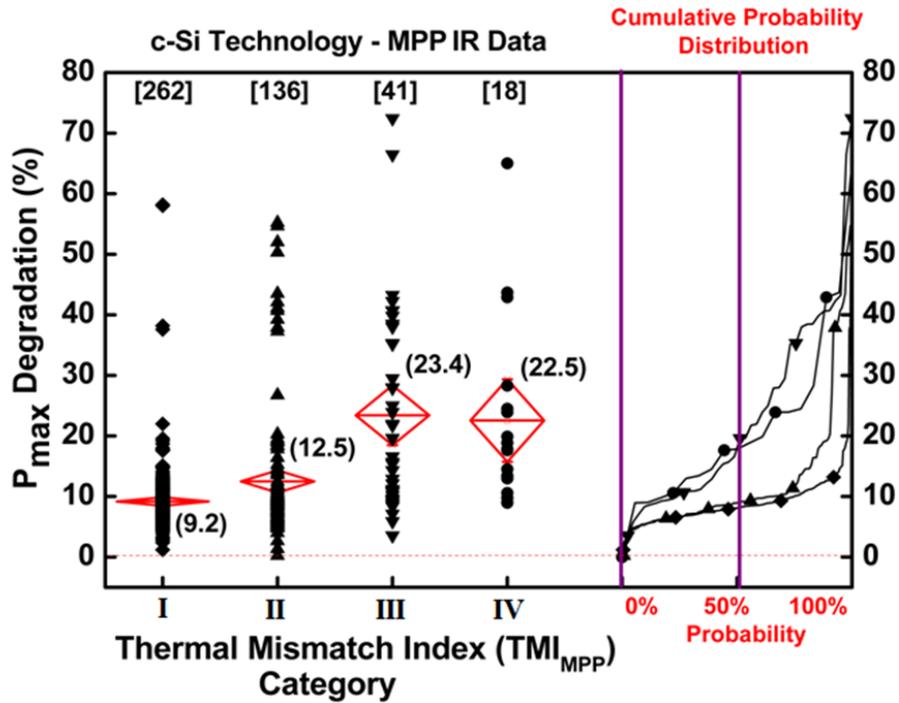
Fig. 6.9: Plot of  $P_{max}$  degradation (%) versus the  $TMI$  category for IR images taken at MPP condition. The red diamonds indicate the 95% confidence interval for the mean value (mentioned inside the round brackets). The number of samples is indicated at the top of the figure in square brackets.

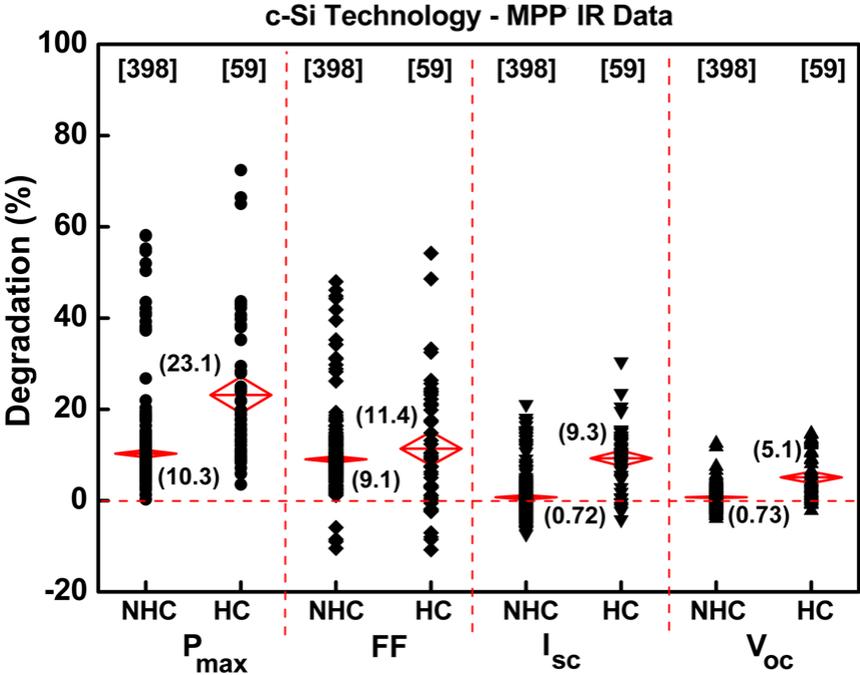
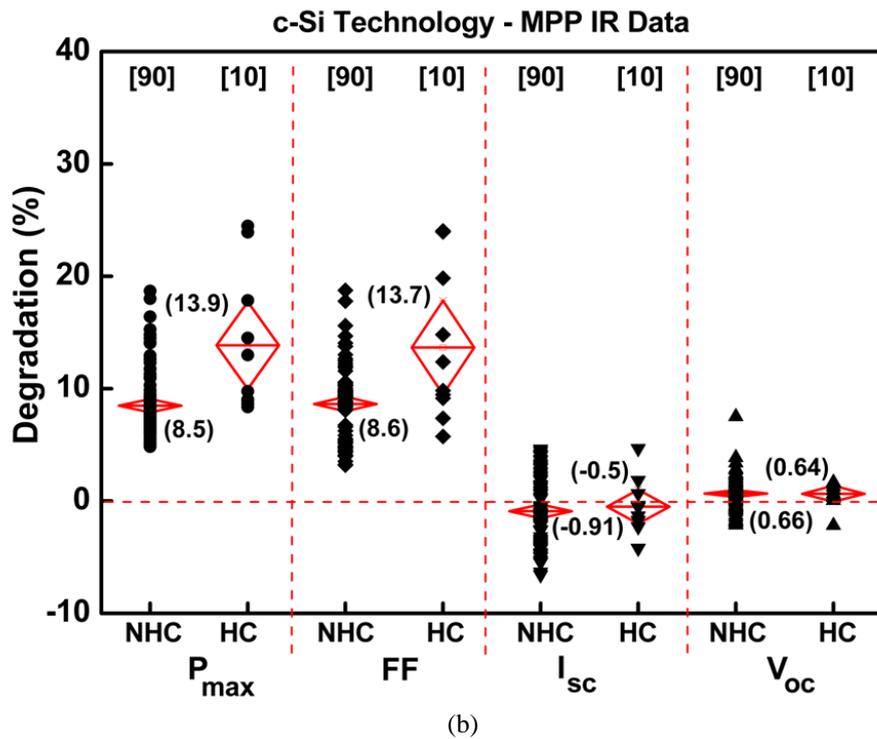
(b)  
 Fig. 6.10: Plot of degradation in electrical parameters (%) for modules with Hot Cells (HC) and without Hot Cells (NHC), for (a) all c-Si sites, and (b) c-Si sites aged less than 10 years having modules with Hot Cells. The red diamonds indicate the 95% confidence interval for the mean value (mentioned inside the round brackets). The number of samples is indicated at the top of the figure in square brackets.

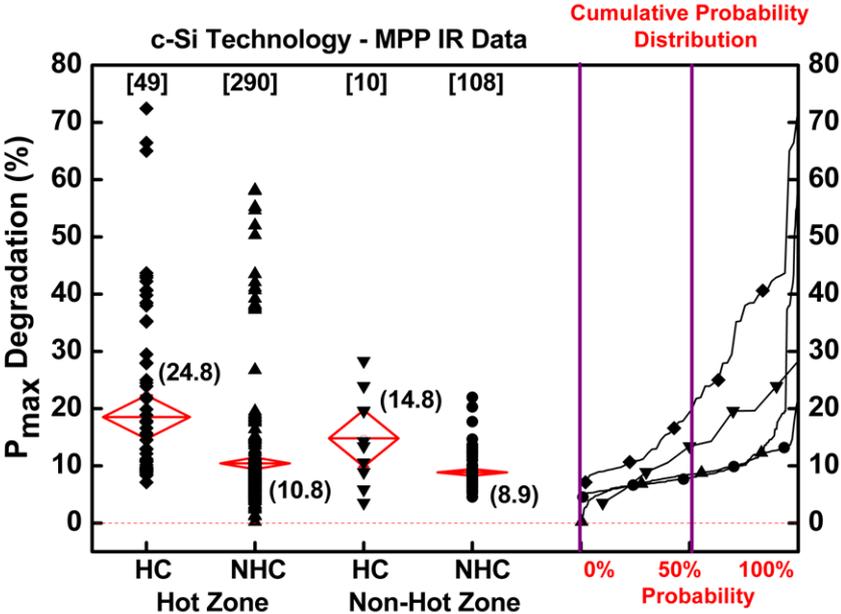
Fig. 6.12: Plot of  $P_{max}$  degradation (%) for modules with and without Hot Cells (HC and NHC) in Hot and Non-Hot zones. The red diamonds indicate the 95% confidence interval for the mean value (mentioned inside the round brackets). The number of samples is indicated at the top of the figure in square brackets.

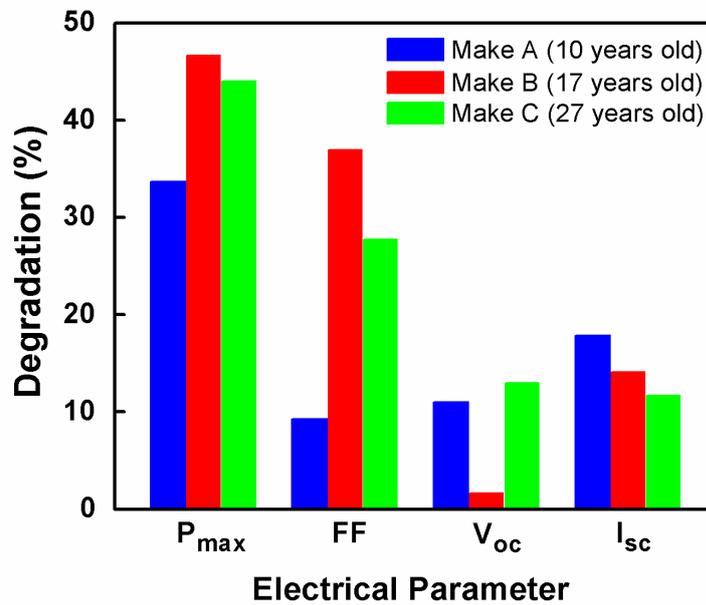
Fig. 6.13: Electrical degradation observed in the modules from Hot Zone showing excessive power degradation.

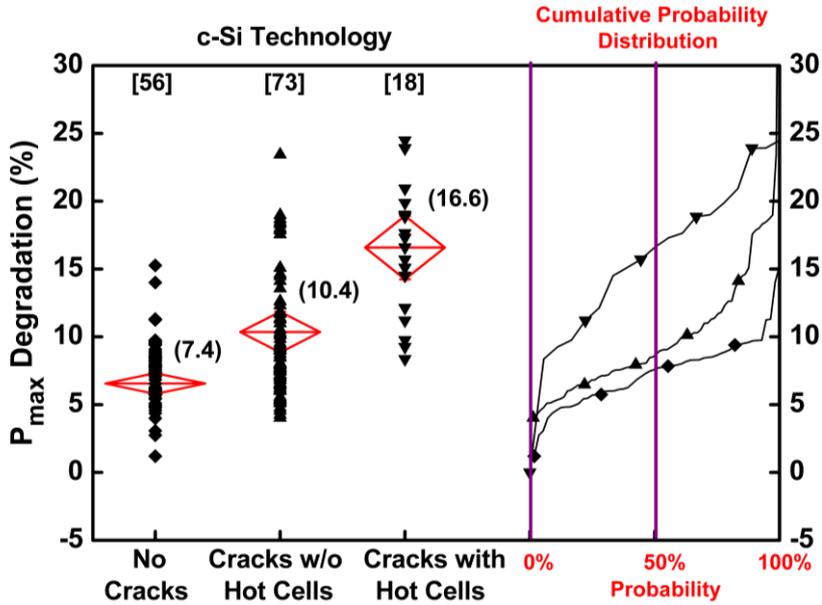
Fig. 6.14:  $P_{max}$  degradation (%) of PV modules with and without cracks and Hot Cells. Cracks have been detected through EL imaging. The red diamonds indicate the 95% confidence interval for the mean value (mentioned inside the round brackets). The number of samples is given at the top of the figure in square brackets.

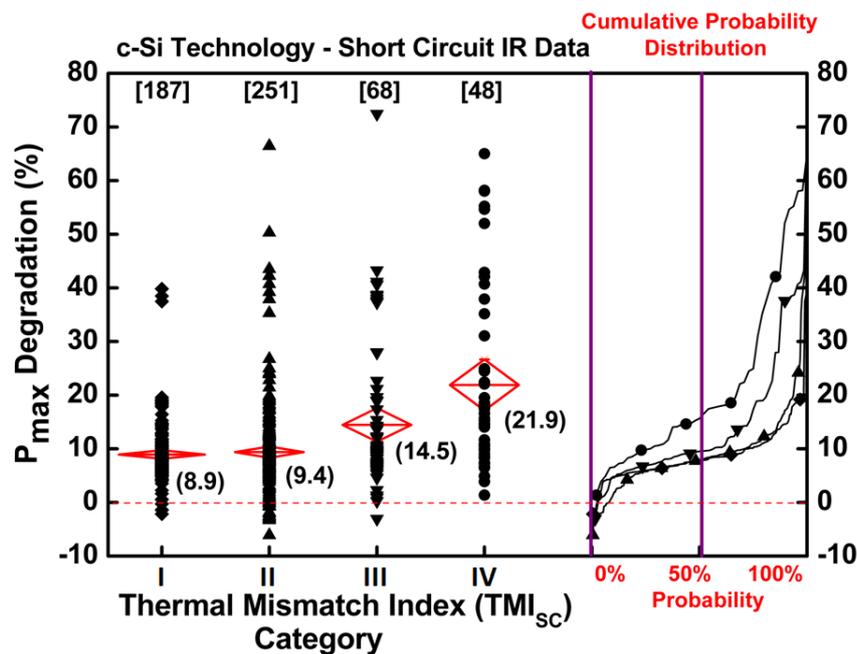
Fig. 6.15: Plot of  $P_{max}$  degradation (%) versus the  $TMI$  category for IR images taken at short-circuit condition. The red diamonds indicate the 95% confidence interval for the mean value (mentioned inside the round brackets). The number of samples is given at the top of the figure in square brackets.

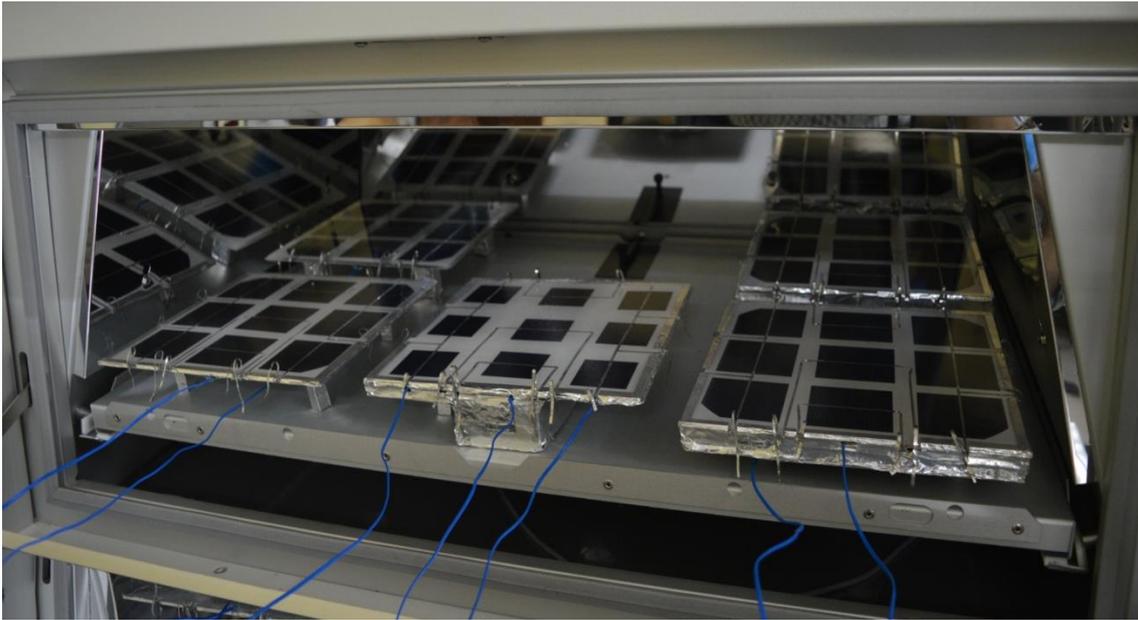
Fig. 7.3: Mini-modules placed inside the Xenon chamber for accelerated testing.

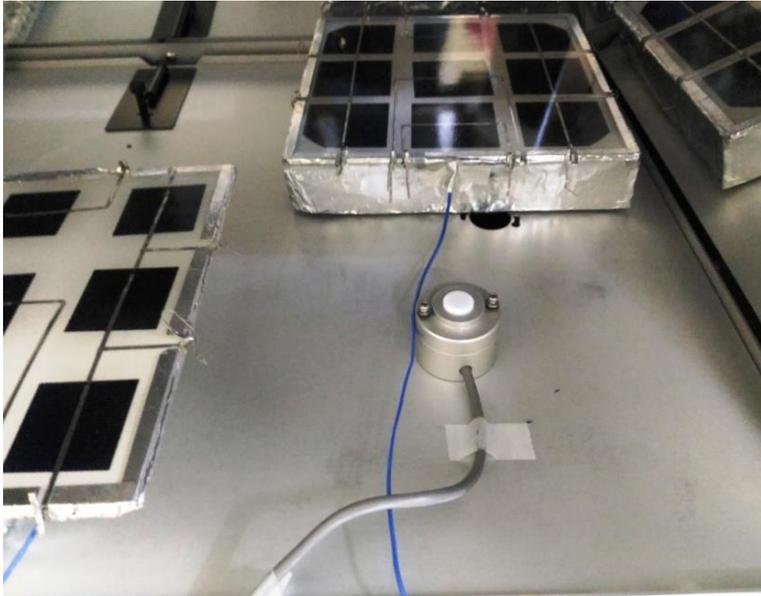
Fig. 7.4: Measurement of the irradiance at the position of the solar cells of sample UVC-3.

The Xenon chamber was calibrated to operate at  $75 \text{ W/m}^2$  total UV intensity (which is the maximum rating for this chamber) on the plane of the sample holder. However, since the samples had additional insulation at the back, which raised their height by ca. 5 cm, the effective UV irradiance on top of each solar cell varied depending on the position inside the chamber. A calibrated radiometer (make: Q-Labs, model: CR20) was used to measure the irradiance at the center of each solar cell (in the presence of the other mini-modules) as shown in Fig. 7.4. The distribution of the UV irradiance on the samples is shown in Fig. 7.5.

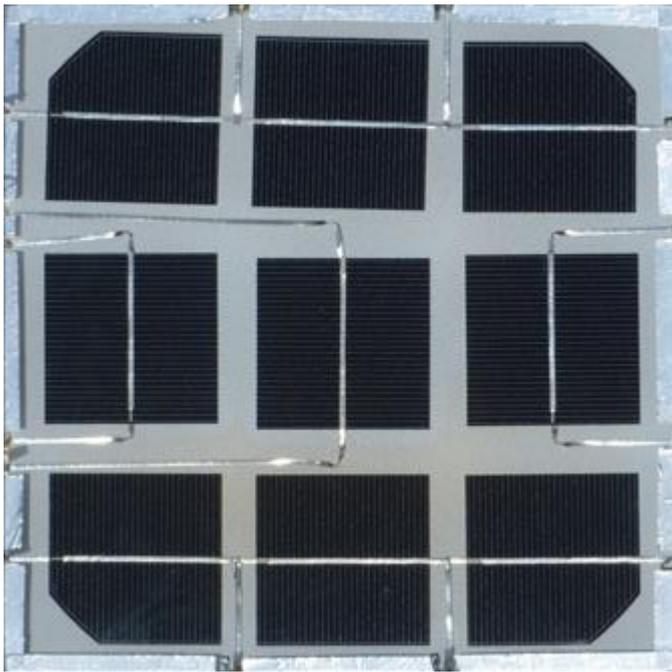
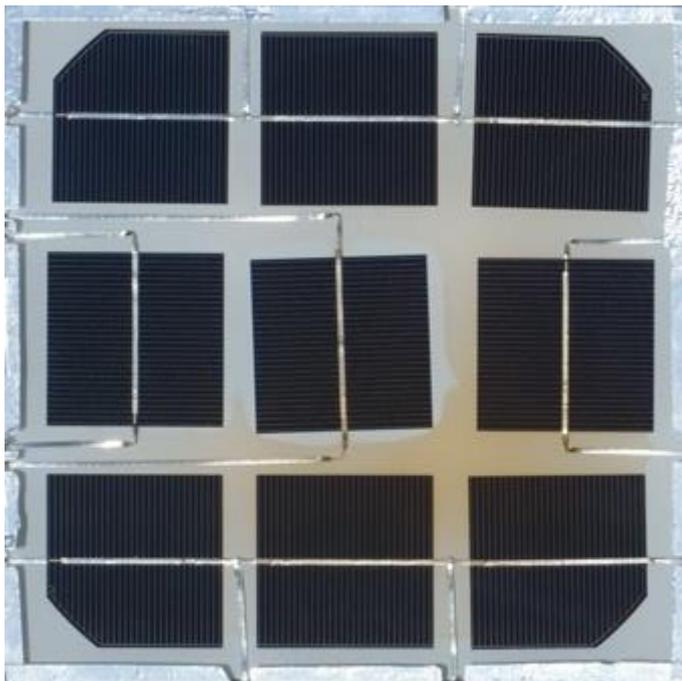
Fig.7.8: Digital images under natural sunlight (left side) and fluorescence images (right side) under 365 nm UV excitation (right side) of the mini-modules taken after ca. 300 kWh/m<sup>2</sup> Xenon-based UV exposure – (a) UVC-1, (b) UVC-2, (c) UVC-3, and (d) UVC-4.

Four mini-modules with UV absorbing EVA were studied in the Xenon chamber. Out of the four samples, sample #1 (UVC-1) did not have any aluminum backing layer. Hence it had maximum photo-bleaching effect due to ingress of oxygen. This is evident from the fluorescence image of the sample shown in the right side of Fig. 7.8(a), wherein the fluorescence is concentrated only at the central portion of the cells, with no fluorescence at the cell edges (due to photo-bleaching). However, no discoloration is visible in the sample (as evident from the image on the left side). Discoloration is visible to the naked eye only in samples UVC-3 and UVC-4, but the fluorescence images clearly show fluorescence at the center of the cells of all four samples. Thus, fluorescence imaging serves as an early indicator of discoloration. There was some amount of oxygen ingress in the aluminum-taped samples as well (samples UVC-2 to UVC-4), along the cuts in the aluminum tape at the edges where interconnect ribbons and the thermocouples had been brought out (as shown in Fig. 7.9). Sample 4 (UVC-4) had an aluminum layer and also maximum insulation thickness, which ensured that most of its cells operated at the highest temperatures. So, the sample UVC-4 showed the maximum yellowing effect (and highest levels of fluorescence). Figure 7.9 explains the different regions in the fluorescence images, and also shows the entry points for oxygen ingress into the laminates. The effect of UV

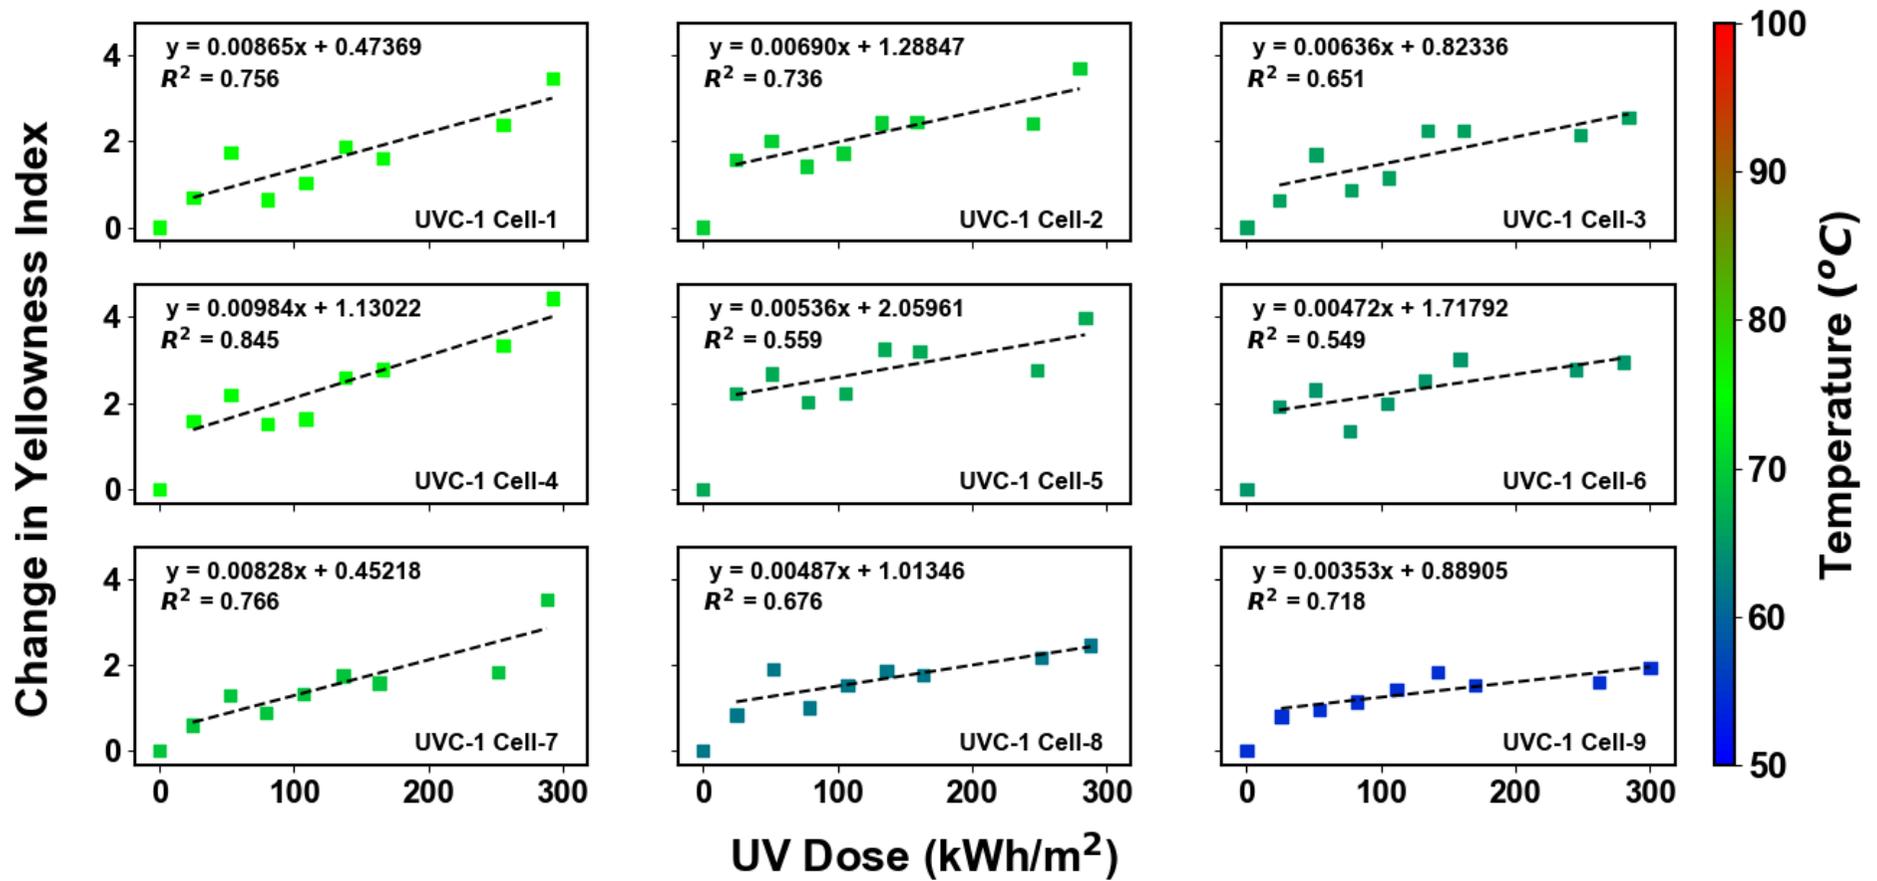
Fig.7.16: Change in *YI* at the center of each cell of sample UVC-1 plotted against UV dose. The straight trend line is fitted to the data points after the initial UV dose of 25 kWh/m<sup>2</sup>. The data points are colour-coded based on the sample temperature.

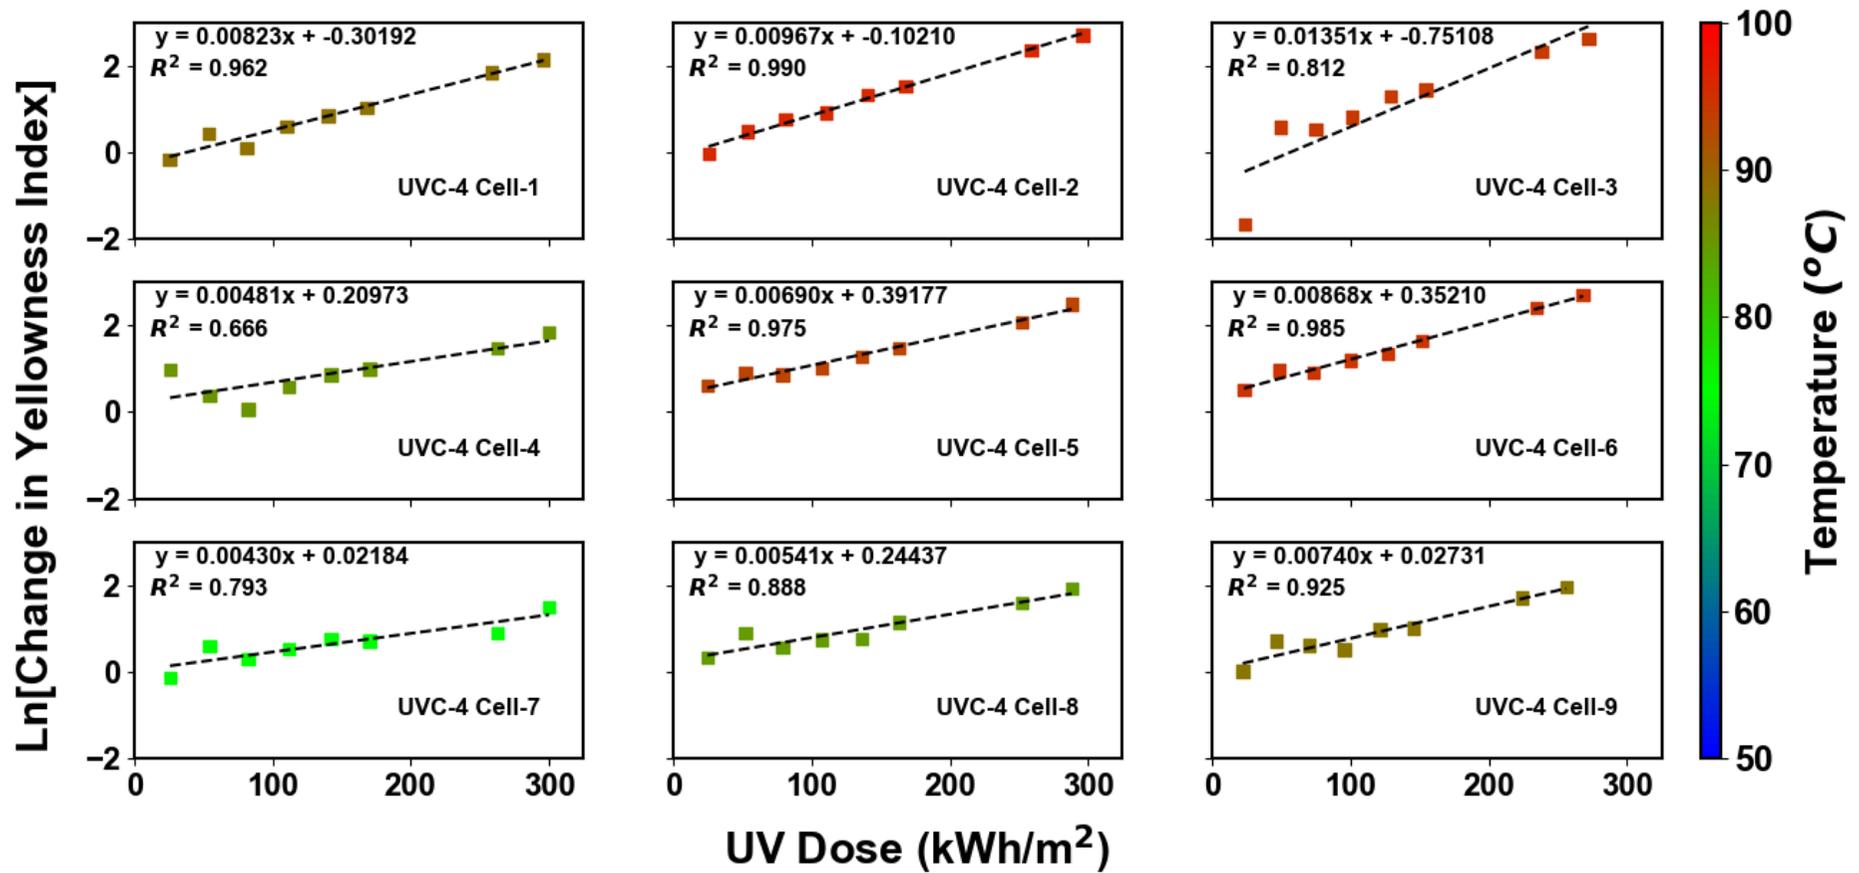
Fig.7.20: Natural logarithm of change in  $YI$  at the center of each cell of sample UVC-4 plotted against UV dose. The straight trend line is fitted to the data points after initial UV dose of 25 kWh/m<sup>2</sup>. The data points are colour-coded based on the sample temperature.

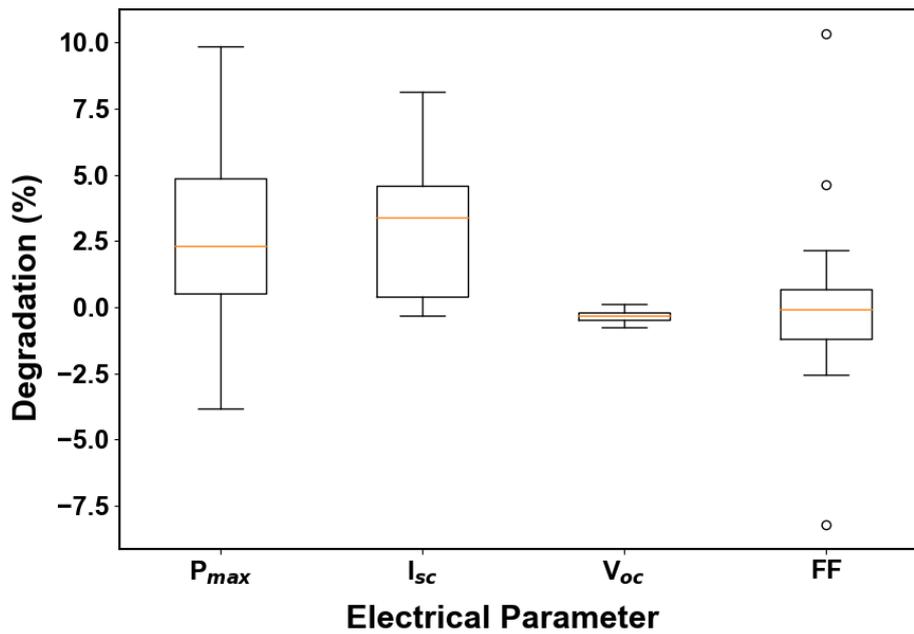
Fig. 7.22: Degradation in electrical parameters in the Xenon chamber tests. The orange horizontal line indicates the median value of the percentage degradation. The boxes indicate the spread of 50% of the data around the median value (between first and third quartiles), and the whiskers indicate the spread of the remaining data points (outside the first and third quartiles, excluding the outliers).

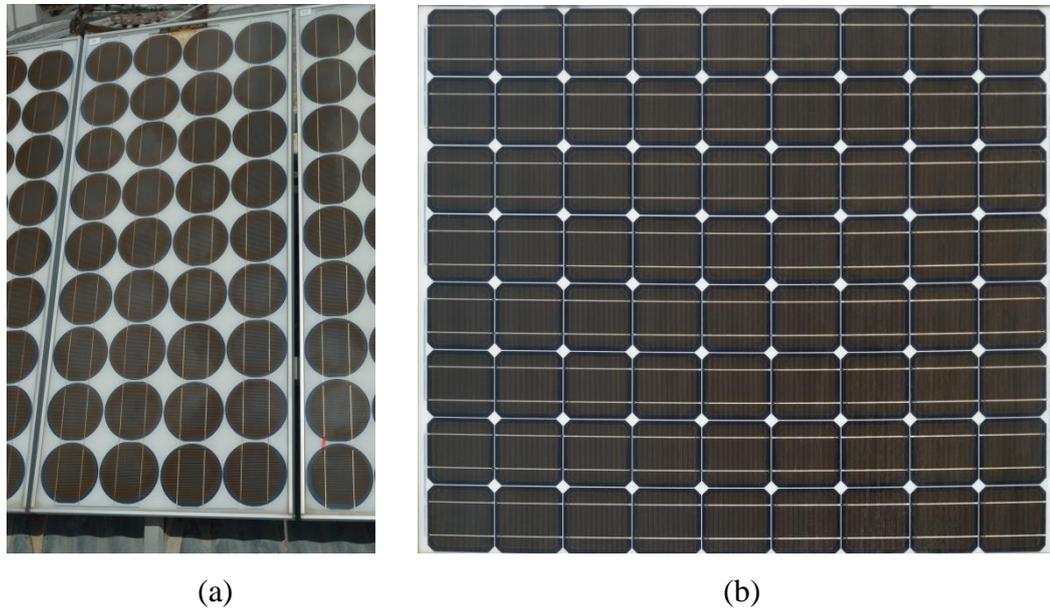
Fig. 7.29: Visual images of discolored PV modules surveyed in 2016 All-India survey – (a) a 18 years old solar panel from Cold & Sunny climate, and (b) a 6 years old solar panel from Warm & Humid climate.
