# **Encapsulant Discoloration in Photovoltaic Modules in Different Climates of India and its Correlation with Hot Cells and Electrical Degradation**

**Doctor of Philosophy**

**Shashwata Chattopadhyay**

Department of Energy Science and Engineering

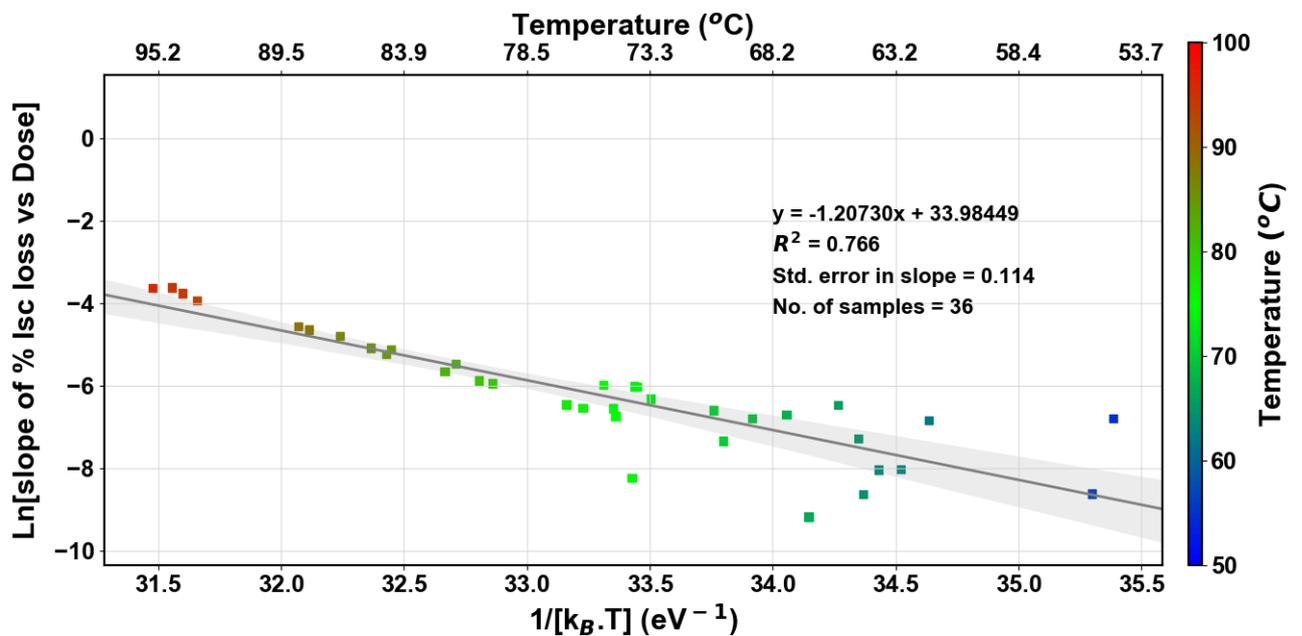
Fig. 7.30: Arrhenius analysis of the slope of  $I_{sc}$  loss versus UV dose. Slope of the linear regression line indicates the activation energy (=1.207 eV). The data points are colour-coded based on the cell temperature during the Xenon chamber tests.

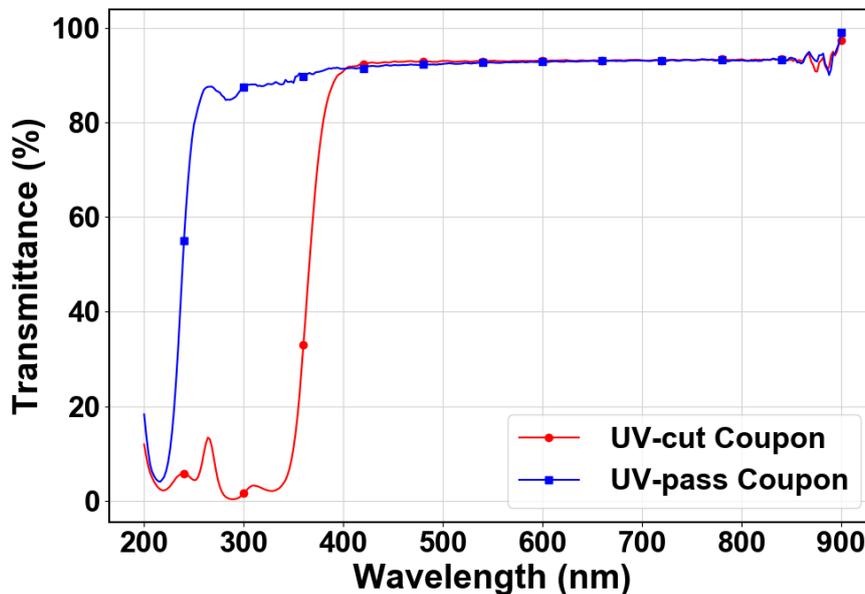
Fig 8.1: Transmittance spectra of UV-cut and UV-pass EVA coupons (laminated between quartz glass sheets). The UV-cut EVA absorbs most of the UV below 350 nm, whereas the UV-pass transmits it.

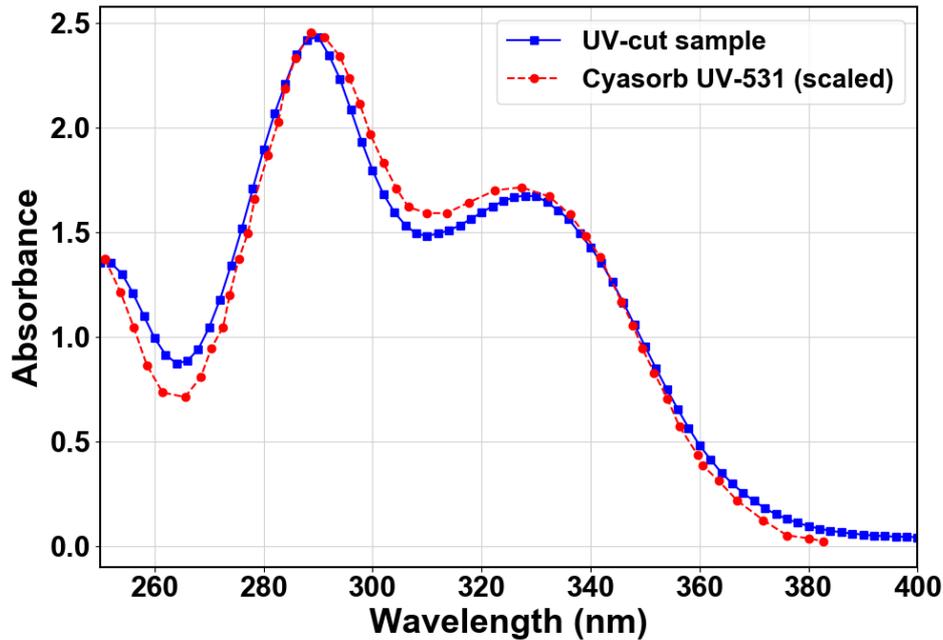
Fig. 8.2: UV absorbance spectra of UV-cut sample (measured) and Cyasorb UV-531 (from datasheet [131]). The close match between the peaks indicates that the additive in the UV-cut sample is Cyasorb UV-531.

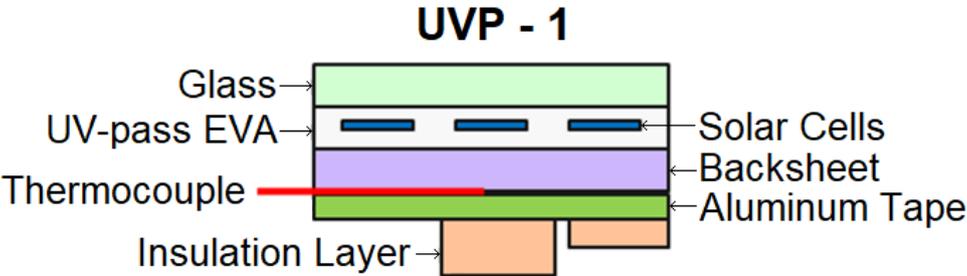
Fig 8.3: Schematic diagram of UV-pass samples (UVP-1) used in the Xenon chamber tests.

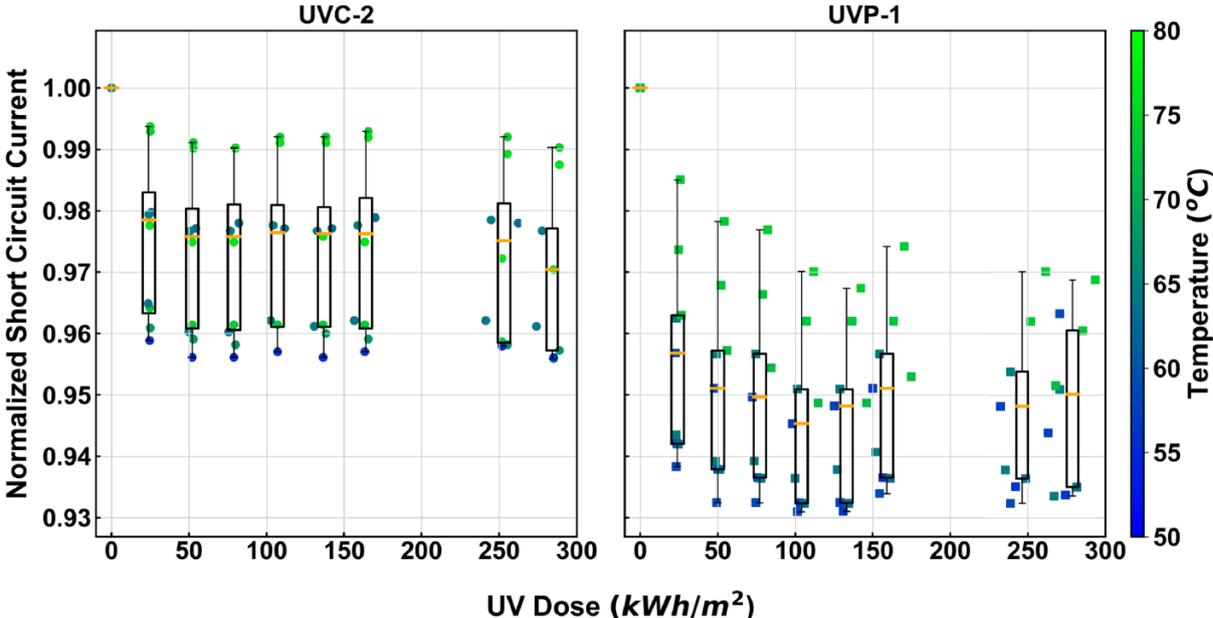
Fig. 8.10: Normalized short-circuit current of UV-cut sample (left) and UV-pass sample (right) versus UV dose in Xenon chamber.

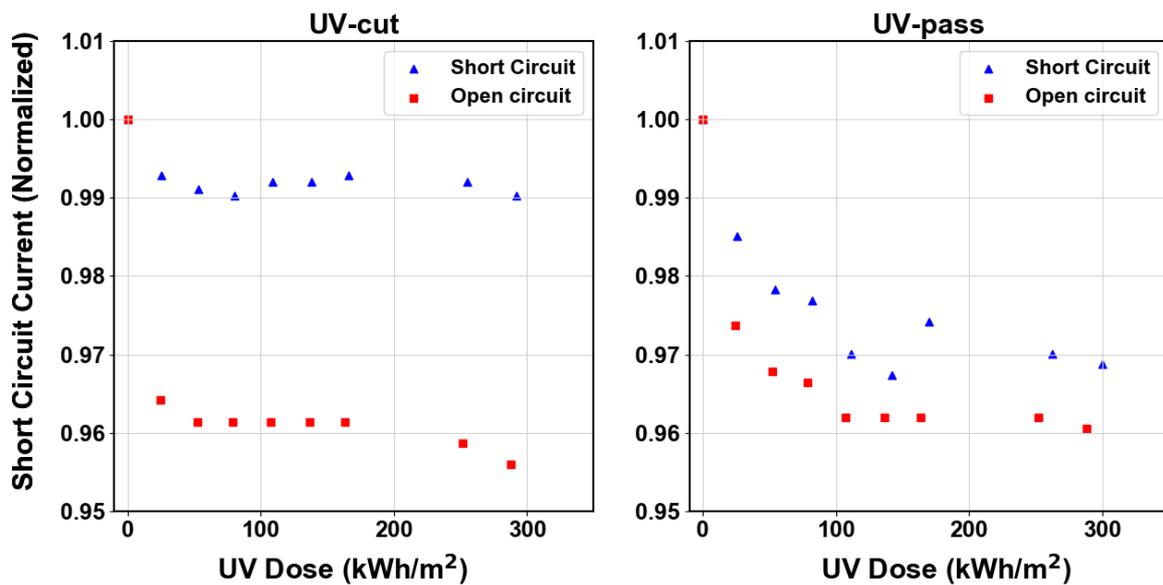
Fig 8.11: Normalized short-circuit current of UV-cut sample (*left*) and UV-pass sample (*right*) versus UV dose under Xenon exposure – Comparison of short-circuit and open-circuit cells at 74 °C sample temperature.

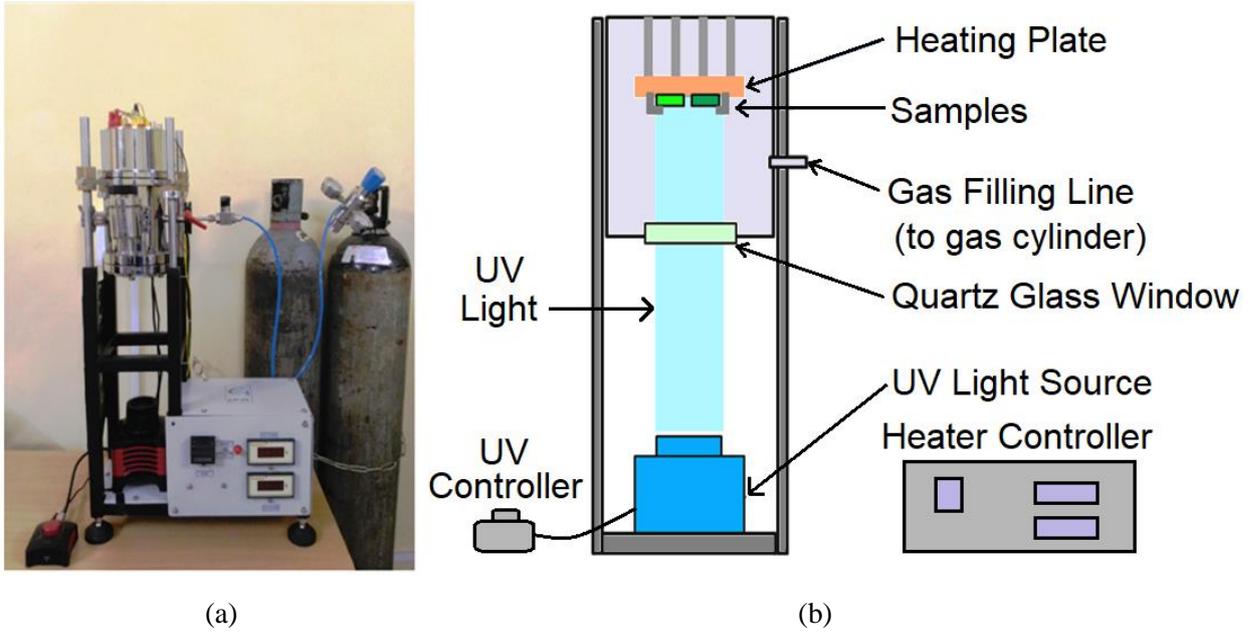
Fig. 8.13: UV-365 test setup – (a) visual image of full setup (b) schematic diagram of the setup.

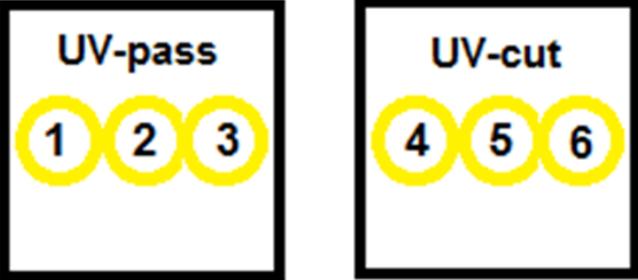
Table 8.2: UV Intensity at different points, measured using photodiode.

Position	UV Intensity (W/m <sup>2</sup> )
		1	382
		2	762
		3	884
		4	878
		5	812
		6	456

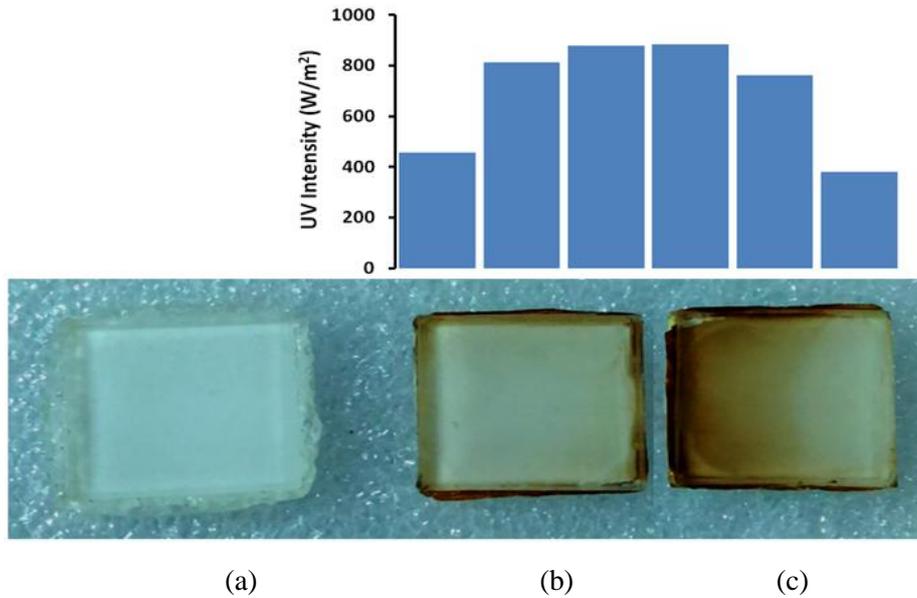
Fig.8.18: Effect of UV-365 exposure on the coupons – (a) unexposed coupon, (b) exposed UV-pass coupon and (c) exposed UV-cut coupon (UV intensity is shown on top of the exposed coupons). Higher discoloration is observed in UV-cut coupon than in UV-pass coupon.

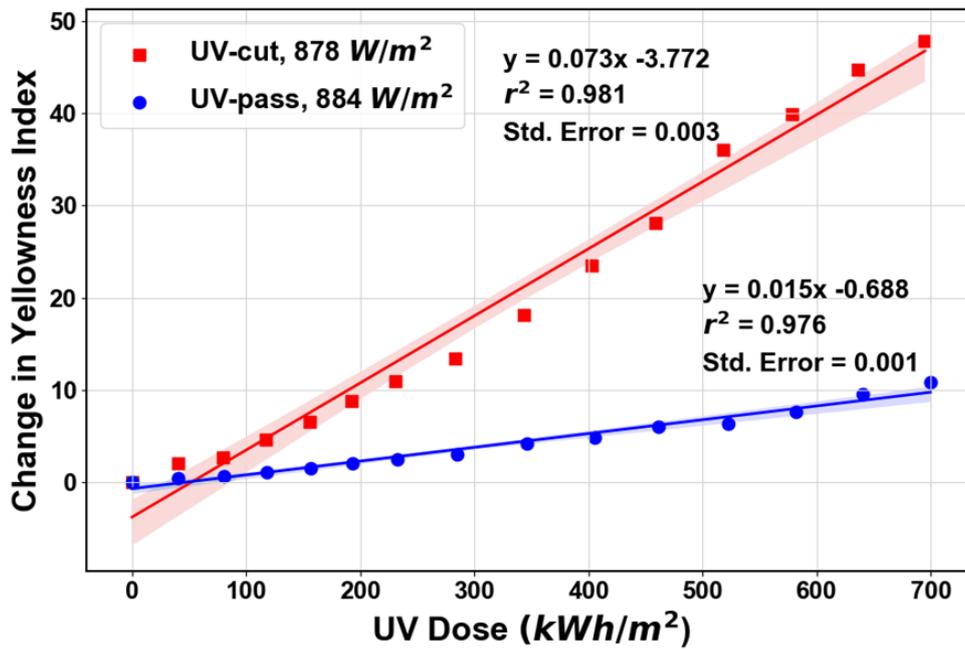
Fig.8.19: Change in *YI* of UV-cut and UV-pass samples, in UV-365 chamber tests (measured at discolored edge, positions 3 & 4 in Table 8.2). Discoloration rate is almost 5 times higher in UV-cut coupon.

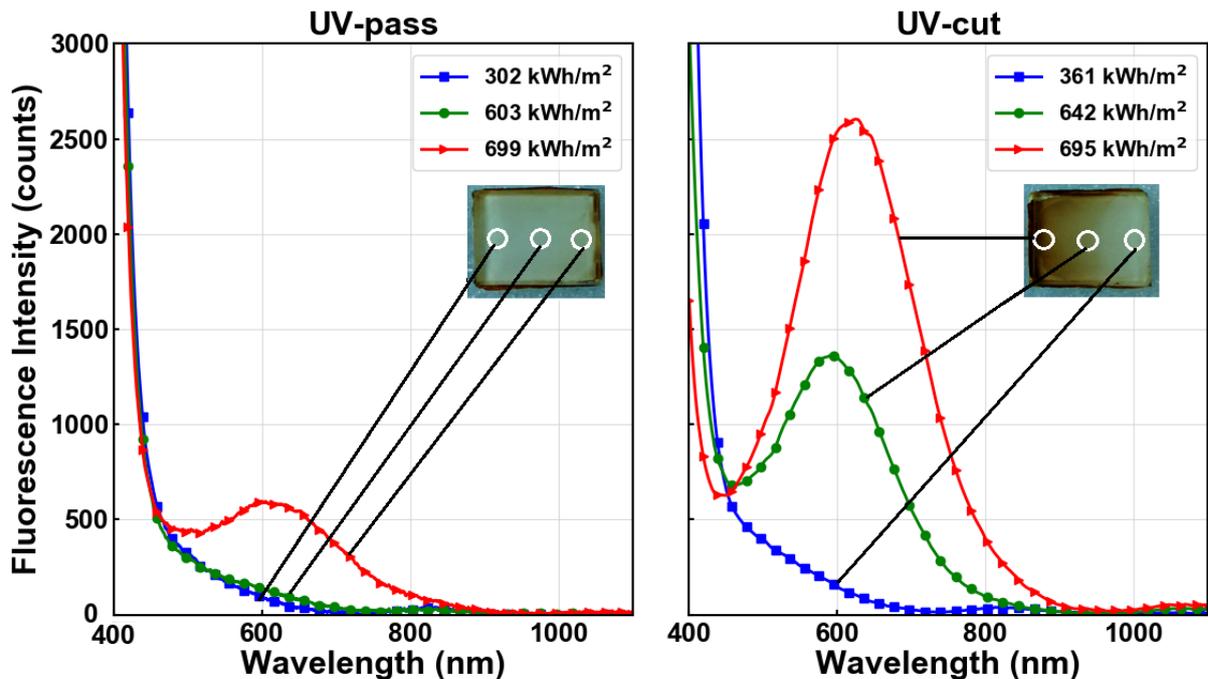
Fig. 8.20: Fluorescence spectra of UV-cut and UV-pass coupons after 700 kWh/m<sup>2</sup> exposure in UV-365 chamber. The peak intensity is almost 5 times higher in UV-cut coupon.

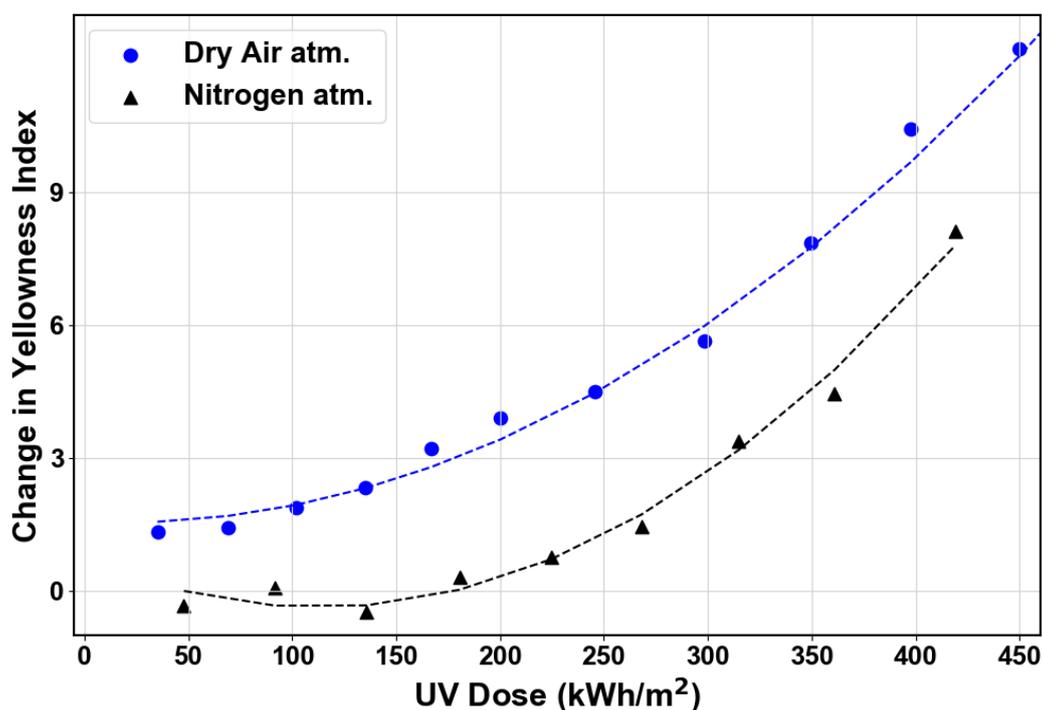
Fig. 8.24: Comparison of discoloration in dry air and nitrogen atmosphere in UV-365 chamber at 90 °C back-plate temperature. The yellowing is higher in presence of oxygen.

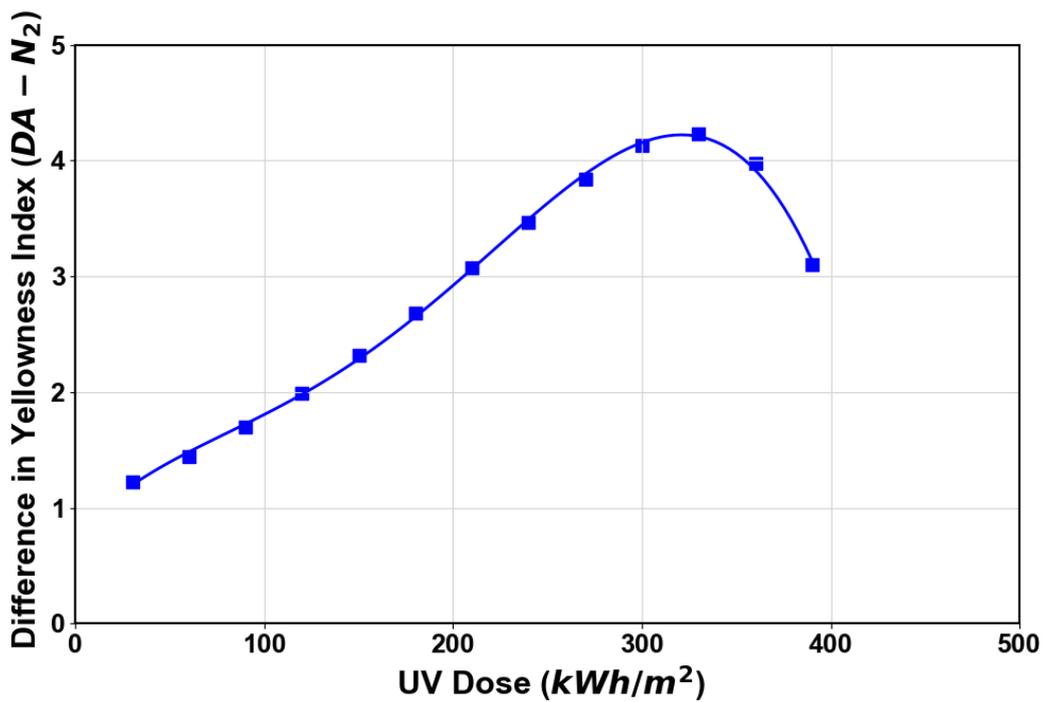
Fig. 8.26: Difference in *YI* of UV-cut coupon between dry air and nitrogen atmosphere, plotted against UV dose. This plot shows the effect of oxygen on discoloration of EVA encapsulant (relative to nitrogen atmosphere).
